*Rubberized Asphalt
&
Stress Absorbing Membrane Interlay*

Serji Amirkhanian, Human Being

May 2026

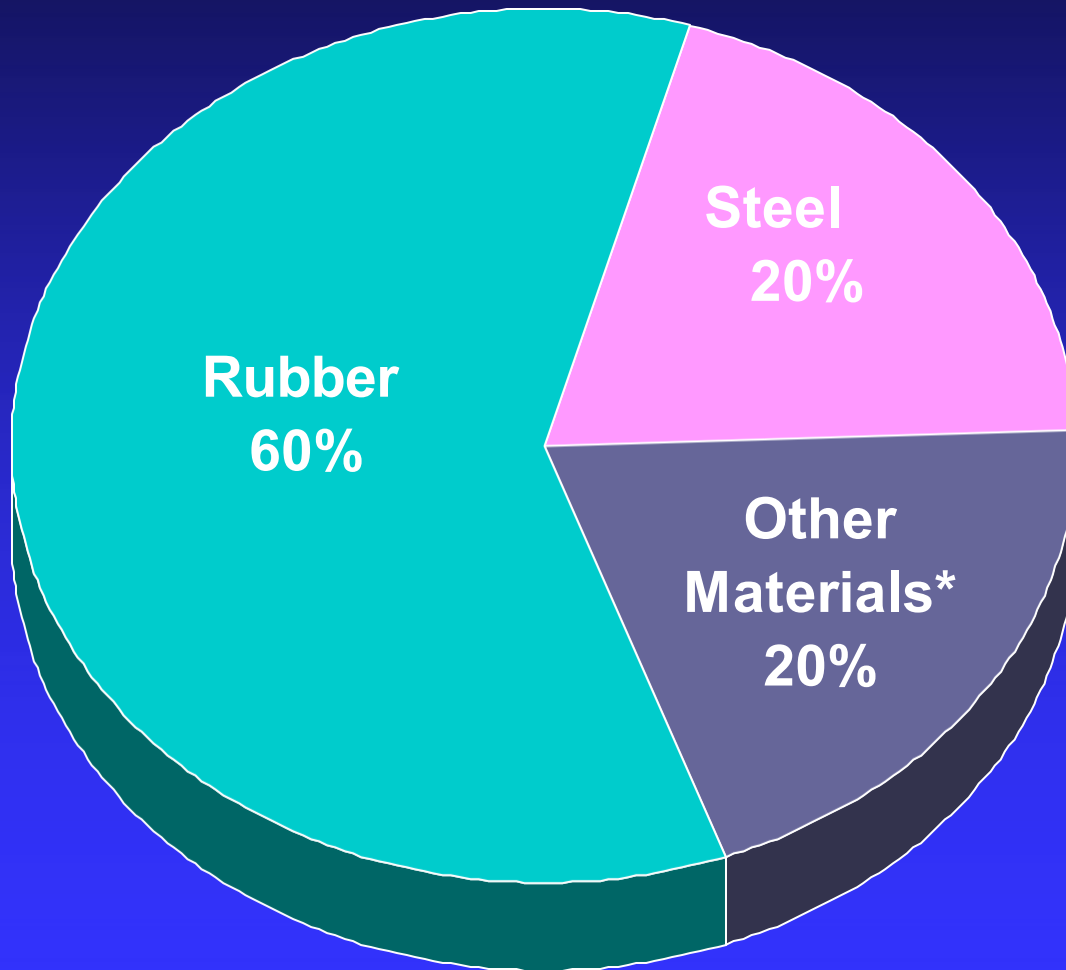
Passenger Car Tire Composition

***Other Materials include fiber, oils, waxes, and pigment**

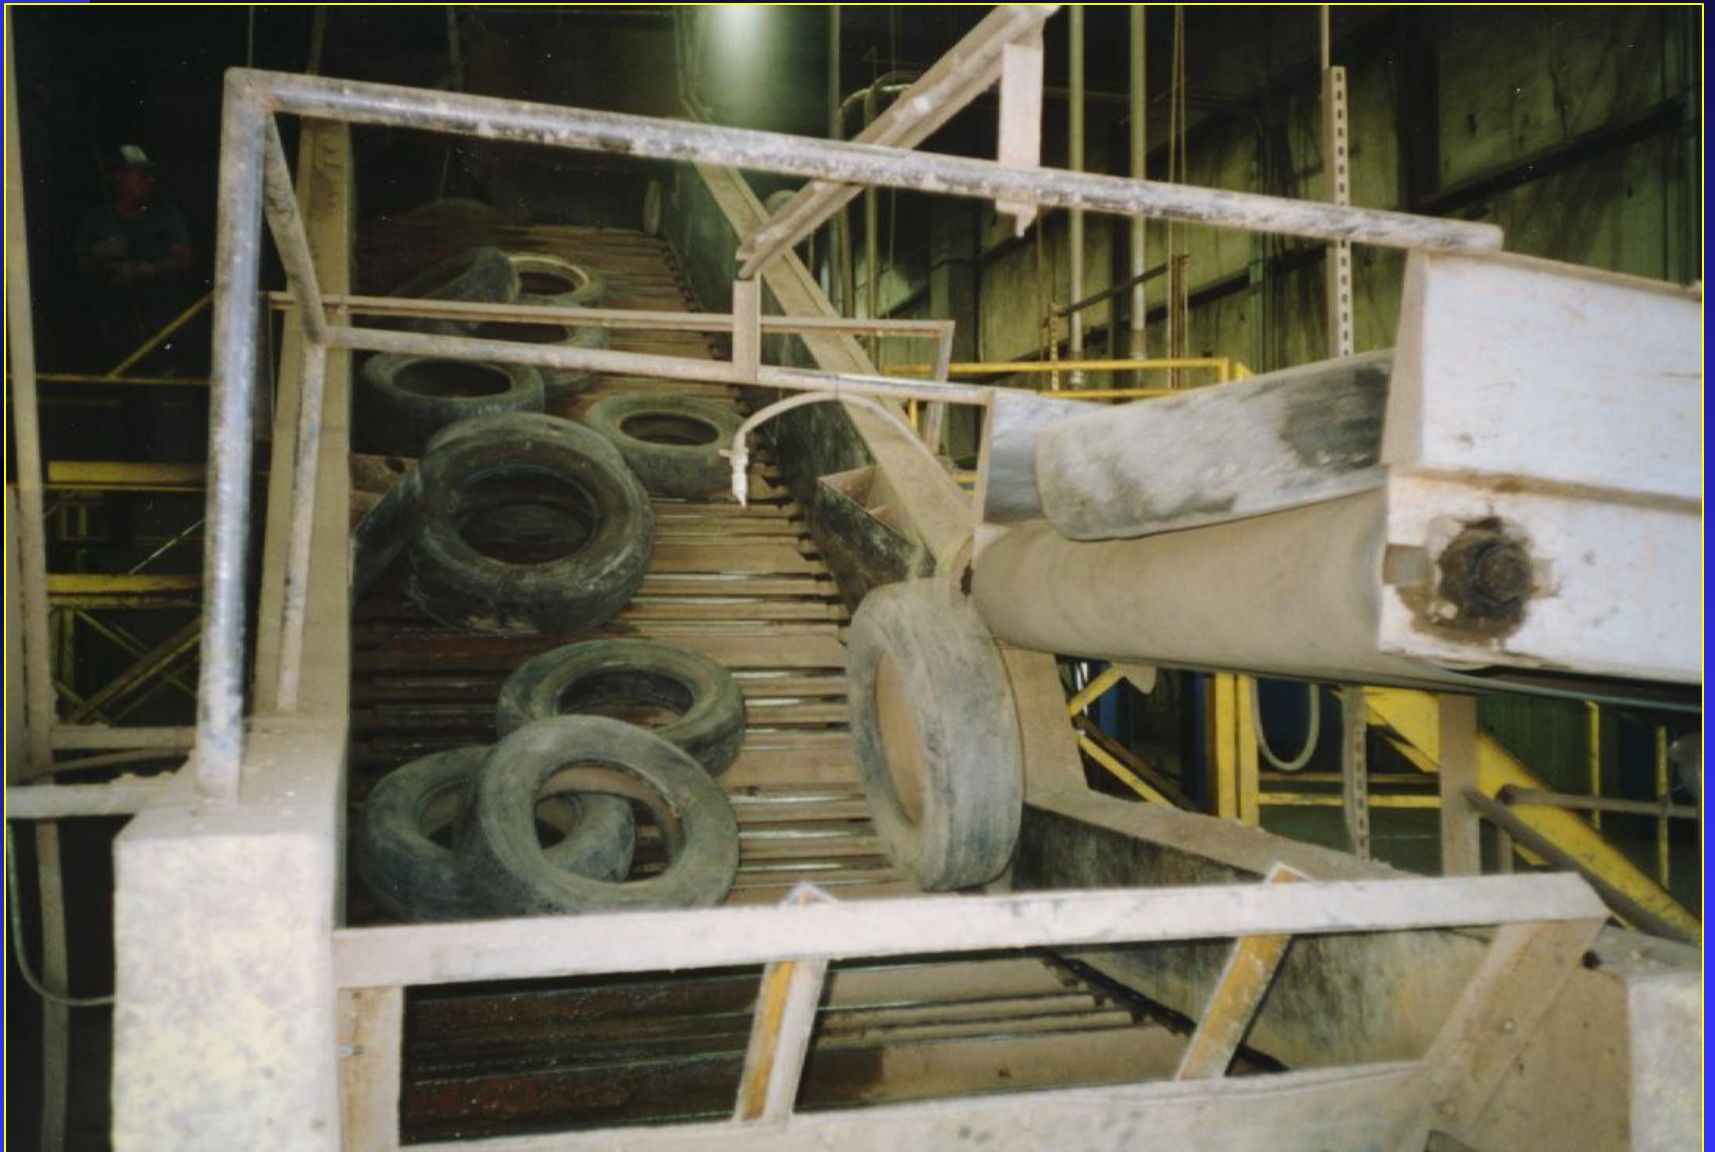
Whole tires fed to primary shredder

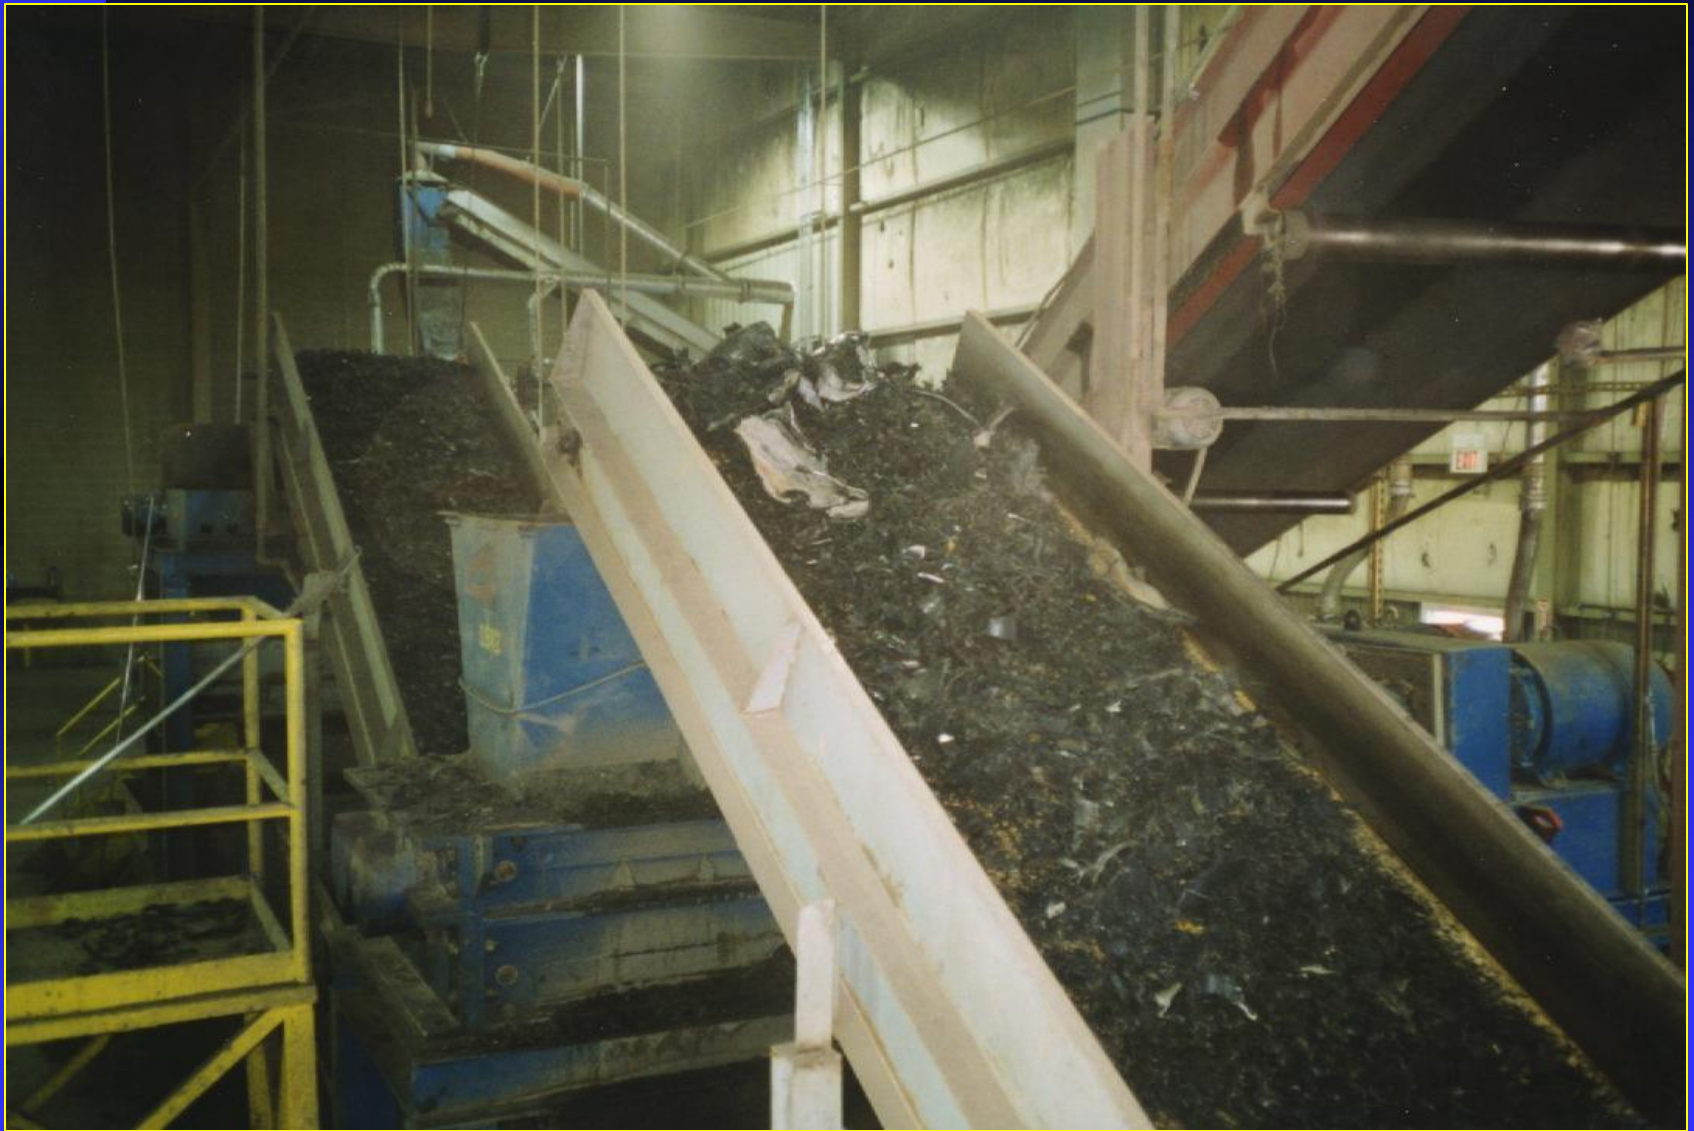
Shreds fed to secondary shredder, steel removed

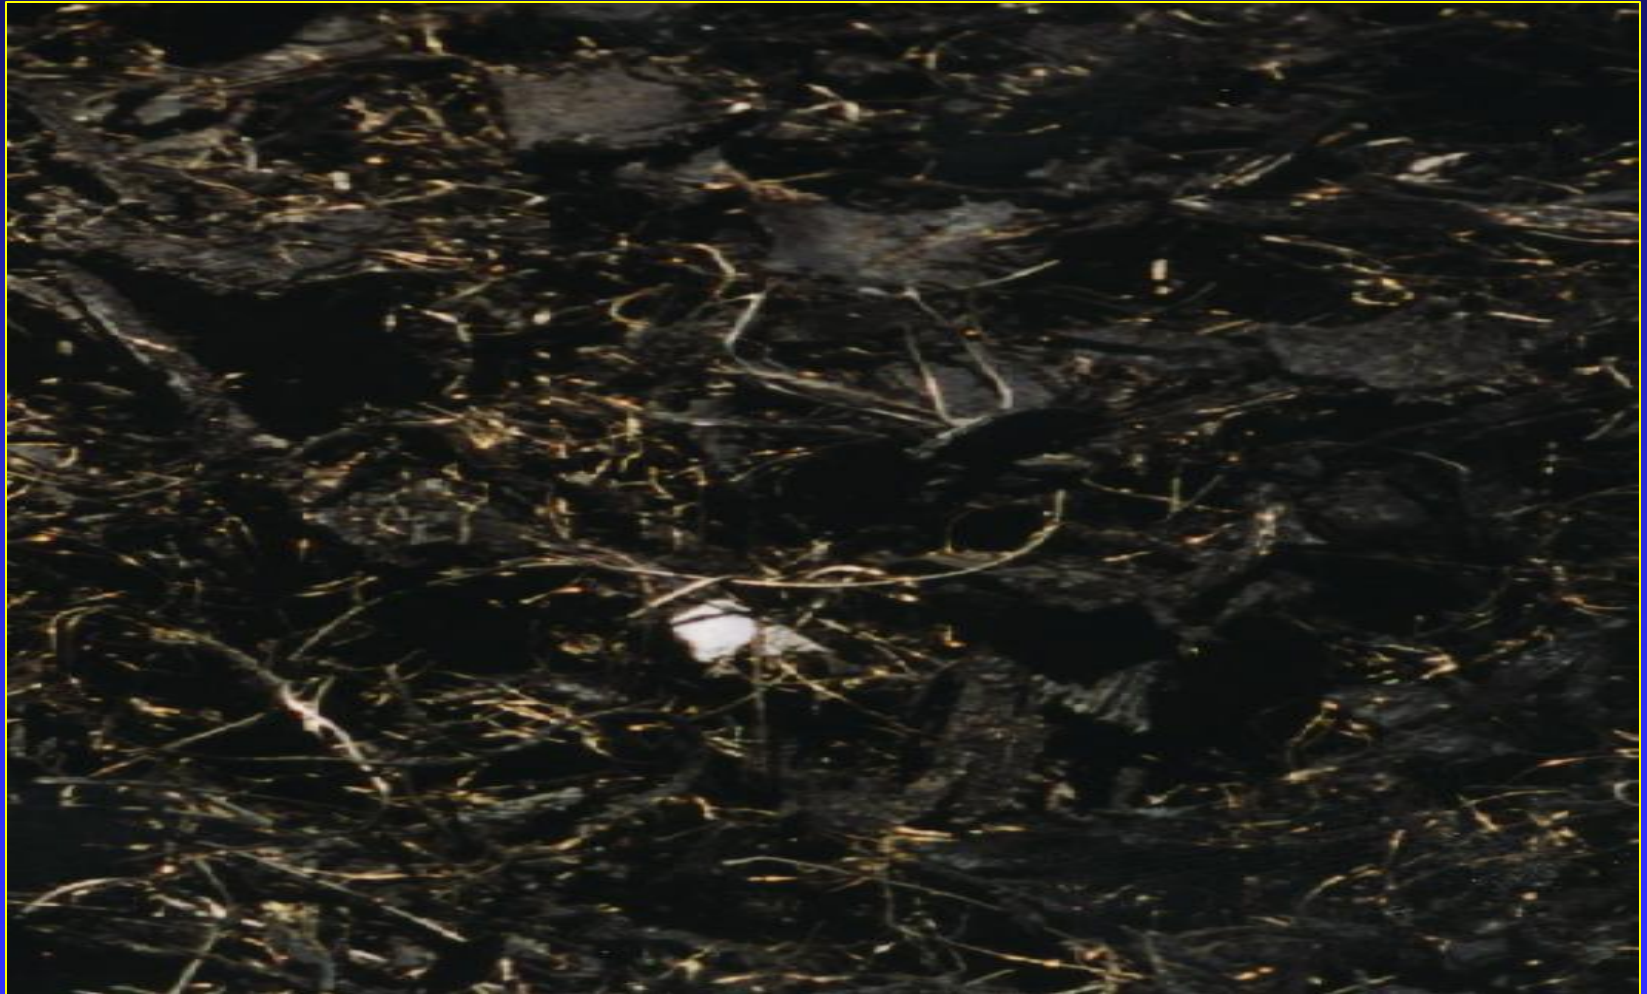
Steel and non-reclaimed rubber from ambient system

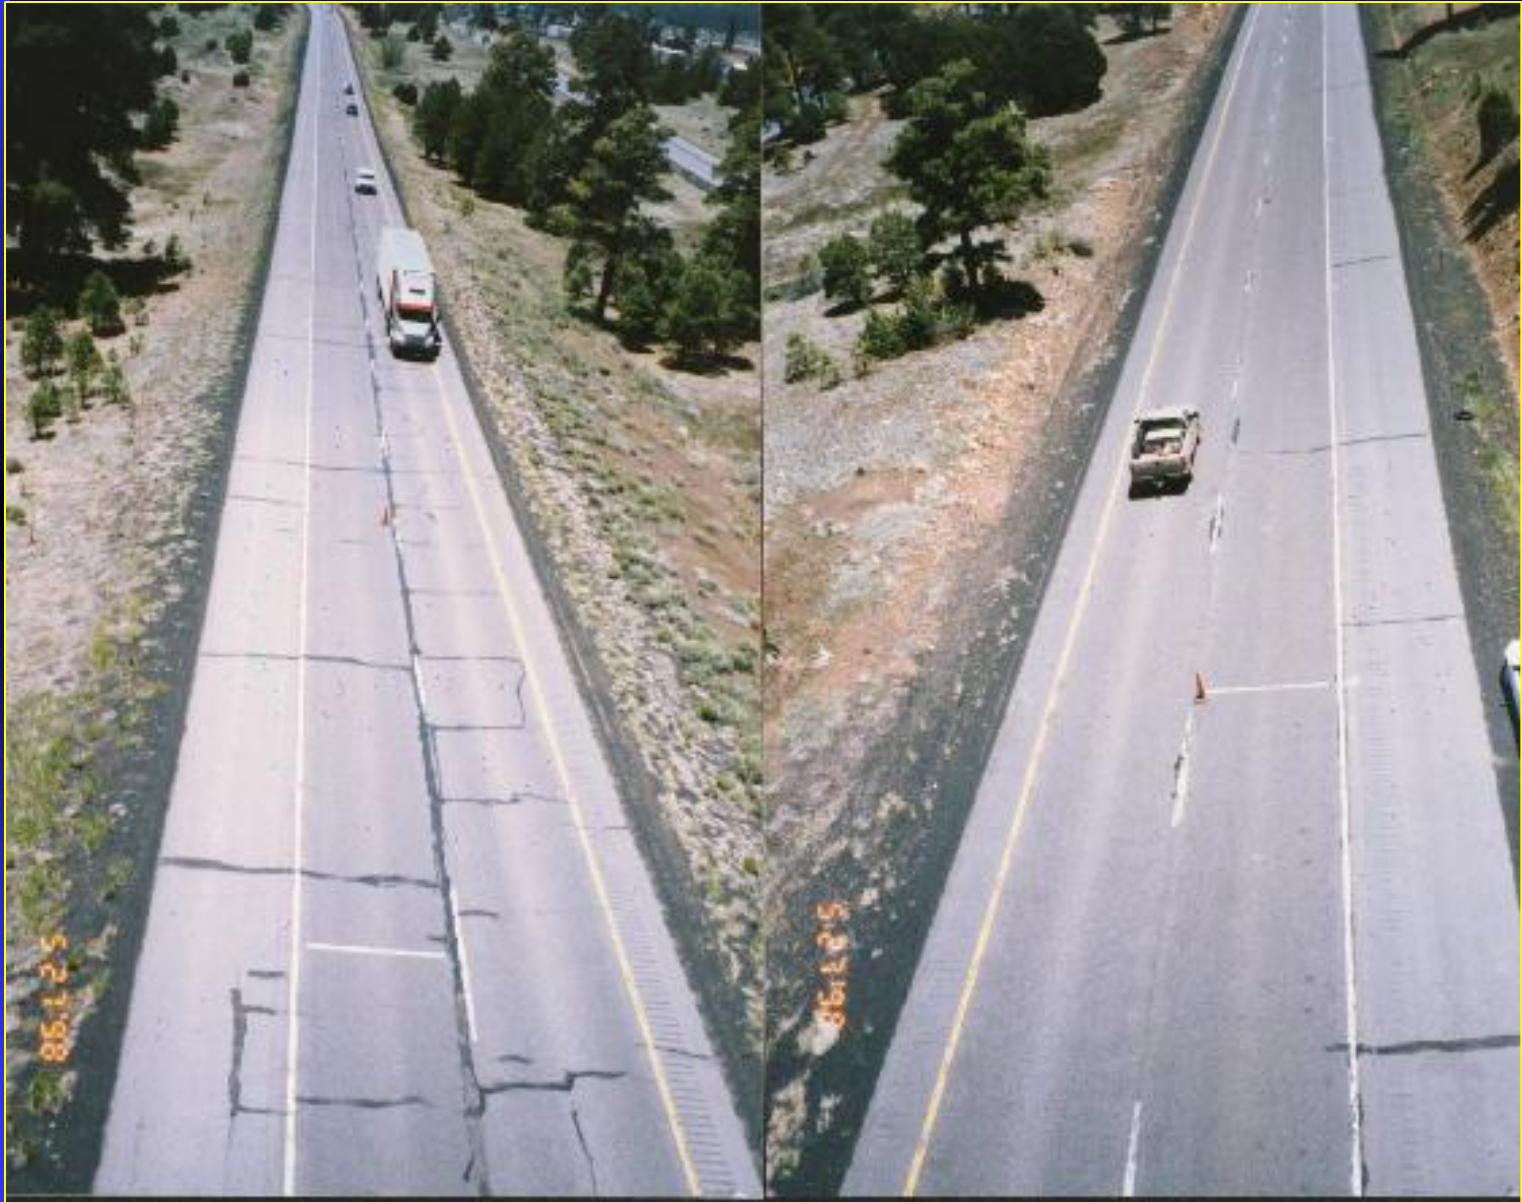
I-40 1998 Appearance After 8 Years Conventional Overlay on Left, Rubber on Right

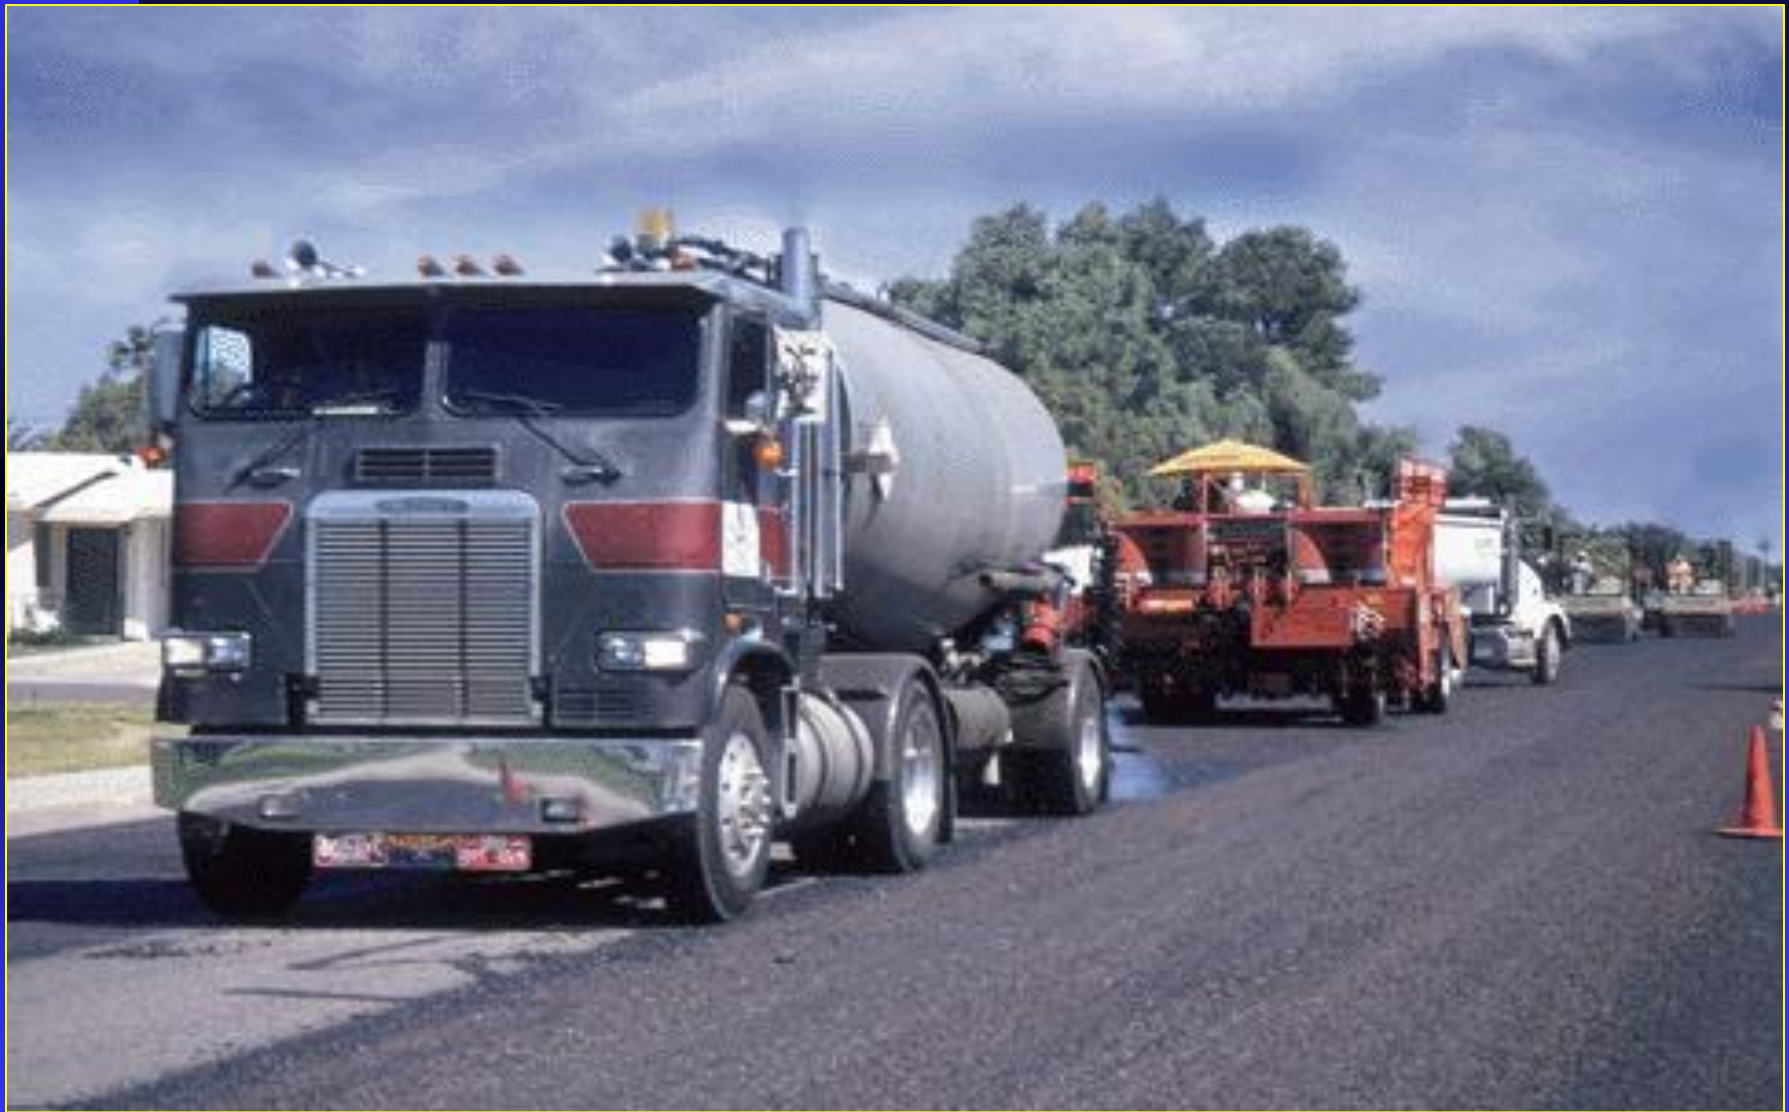
Asphalt-Rubber SAM Application

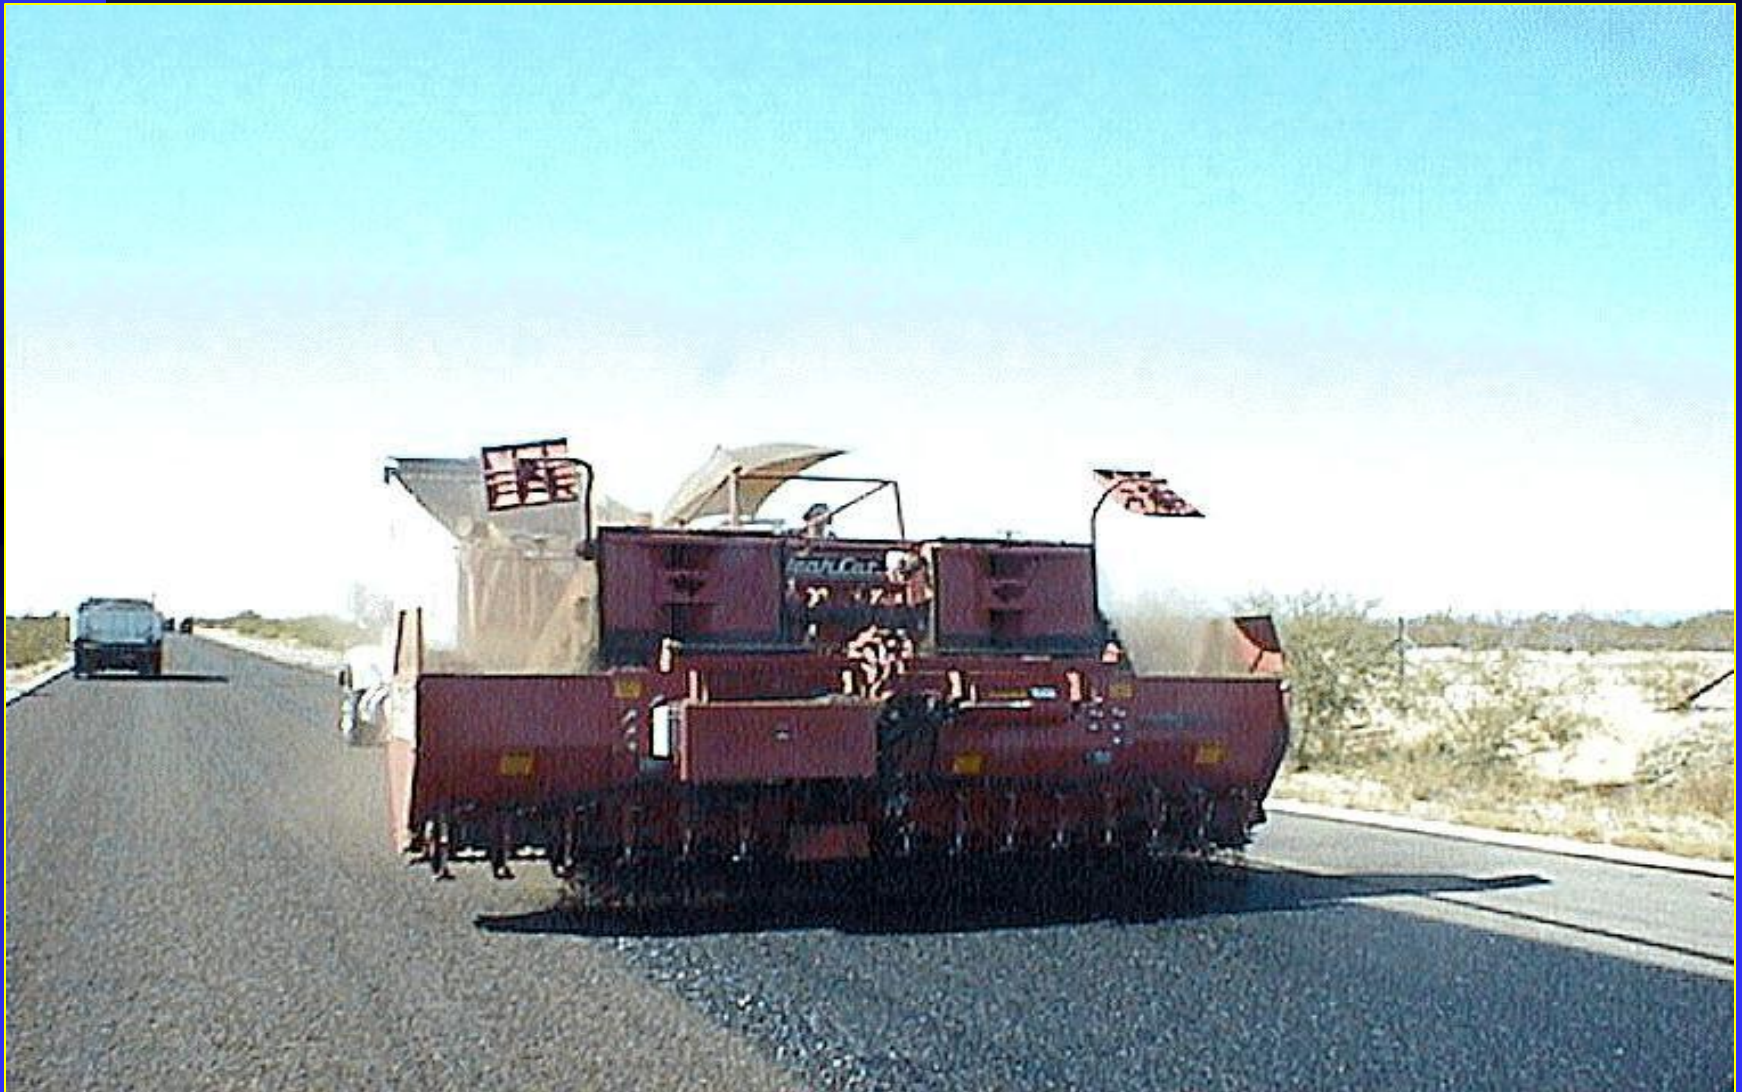
Pre-Coated Aggregate Application

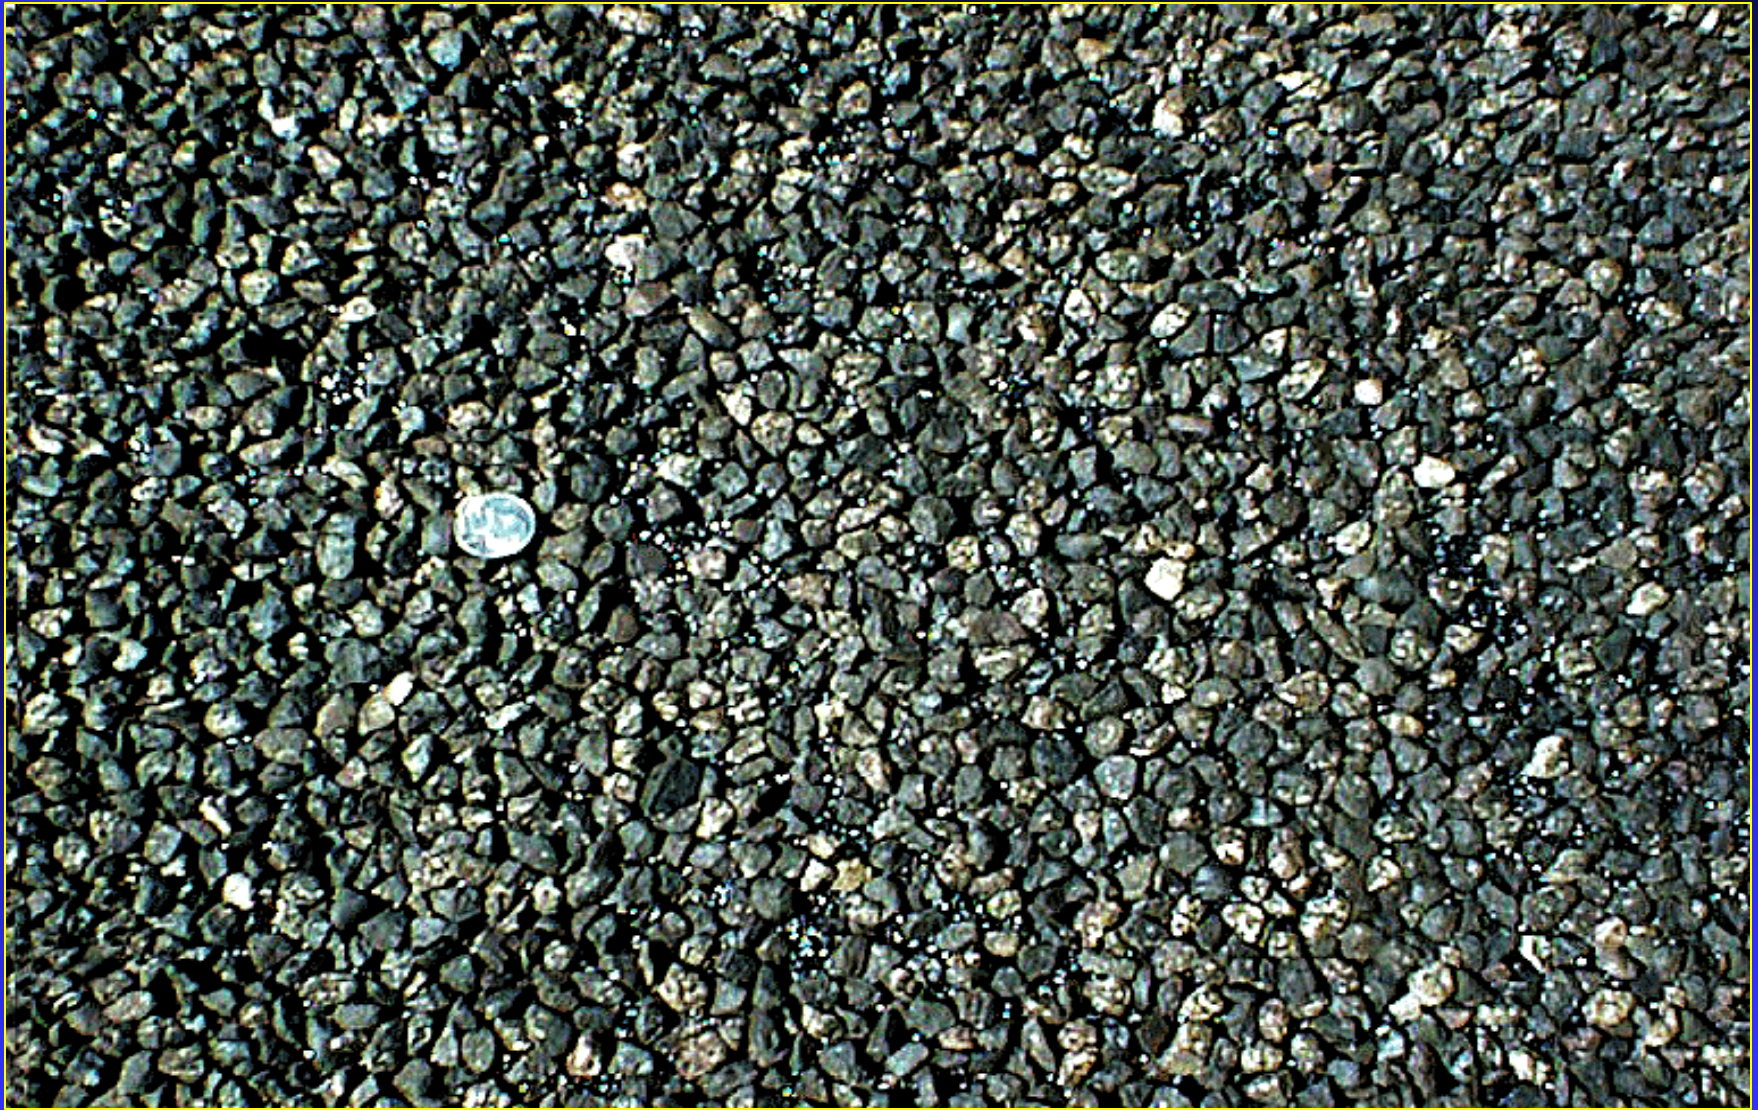
Finished Surface Before Fog Seal

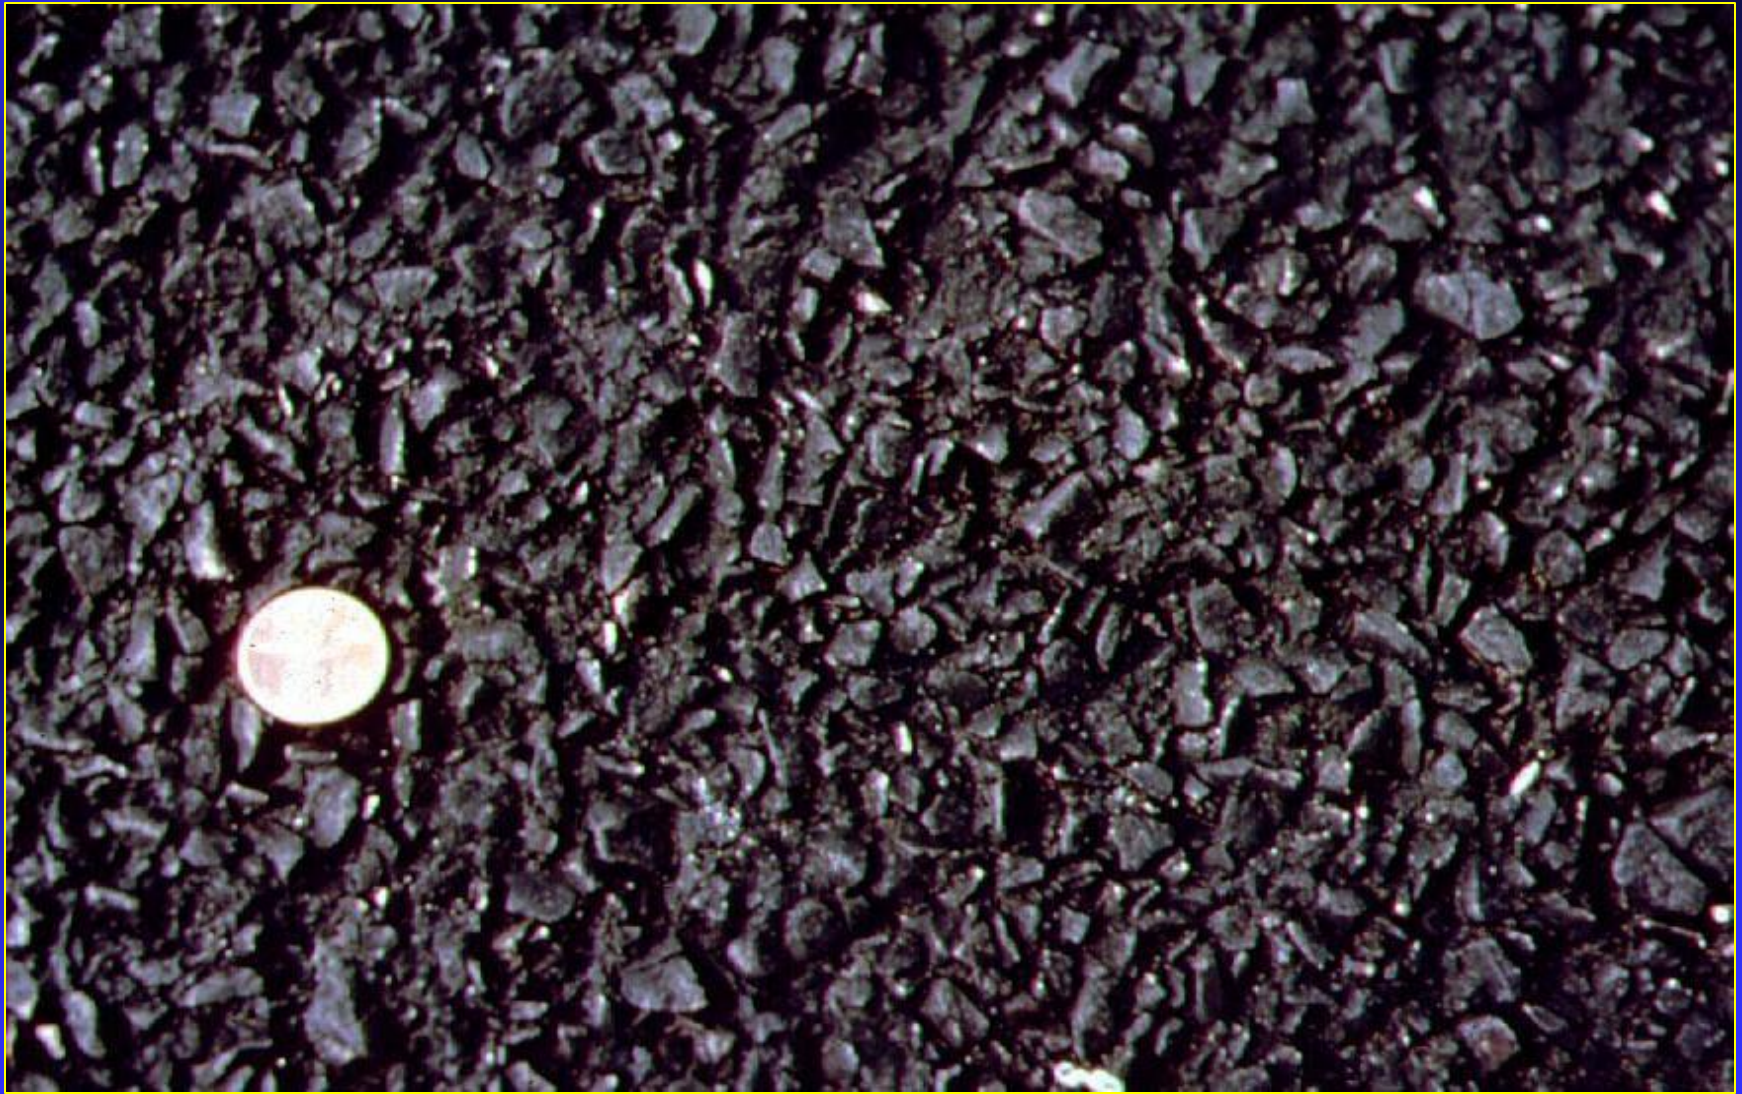
Completed SAM Application (After FOG Seal)

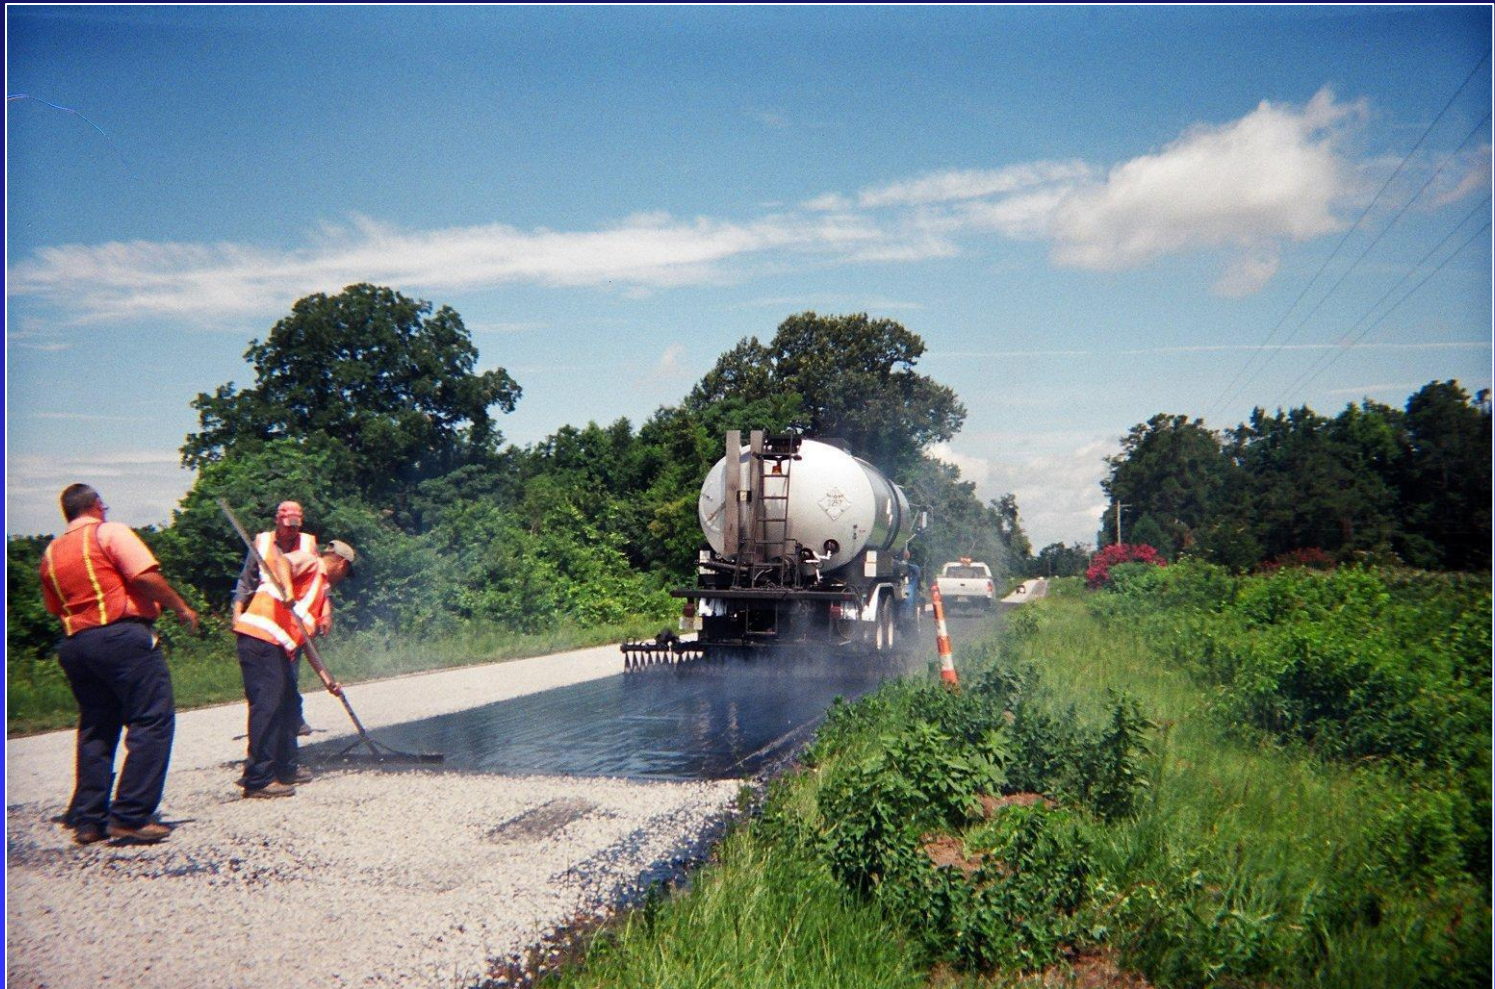
Stress Absorbing Membrane Interlayer Applying Asphalt Binder Layer

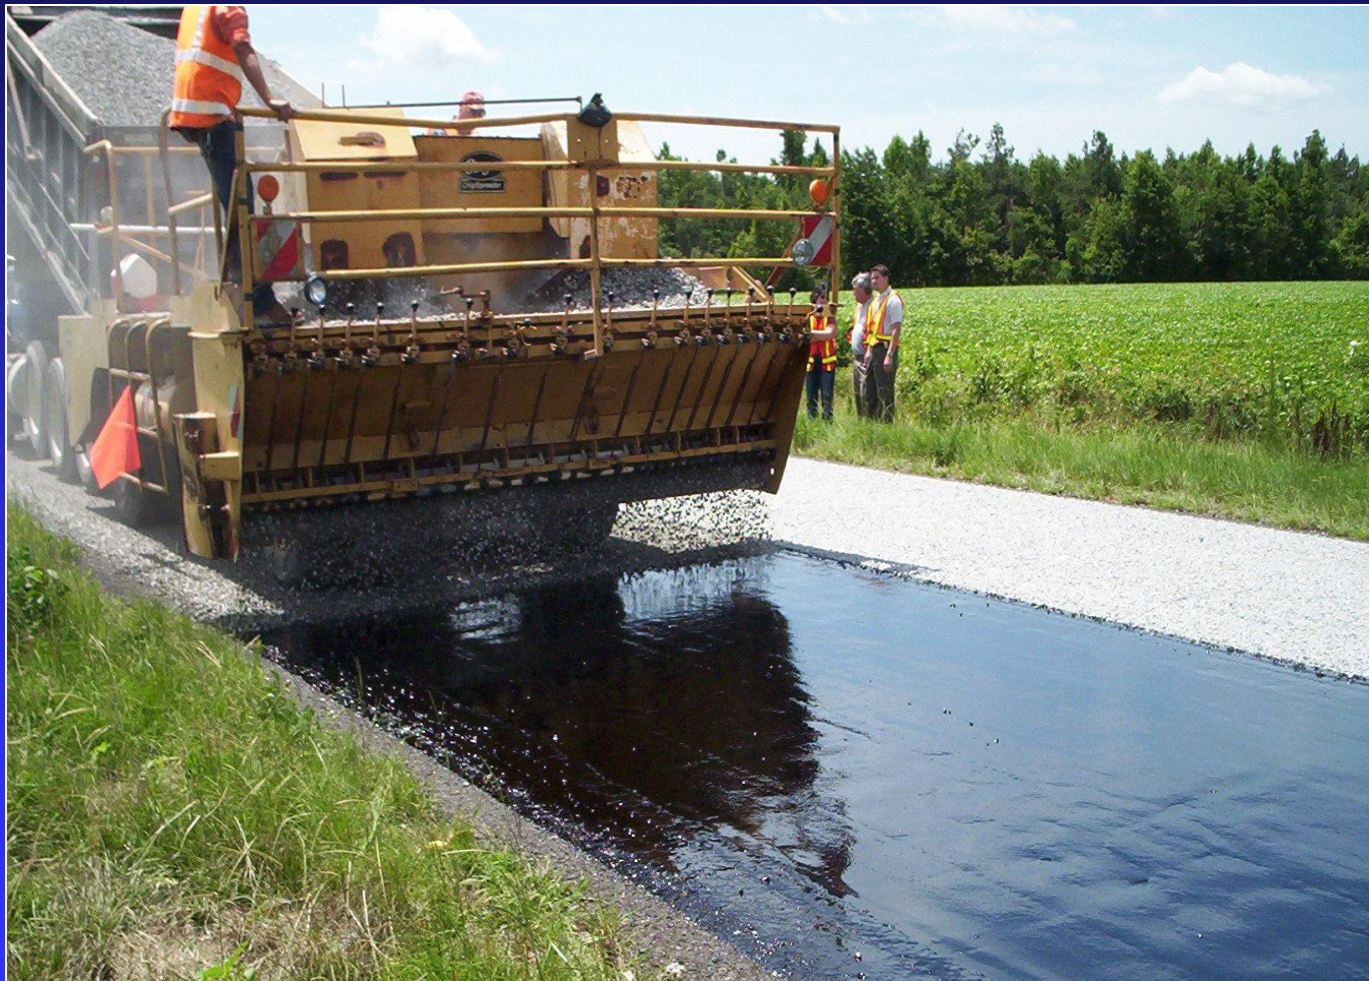
Stress Absorbing Membrane Interlayer Applying Aggregate to Asphalt Binder Layer

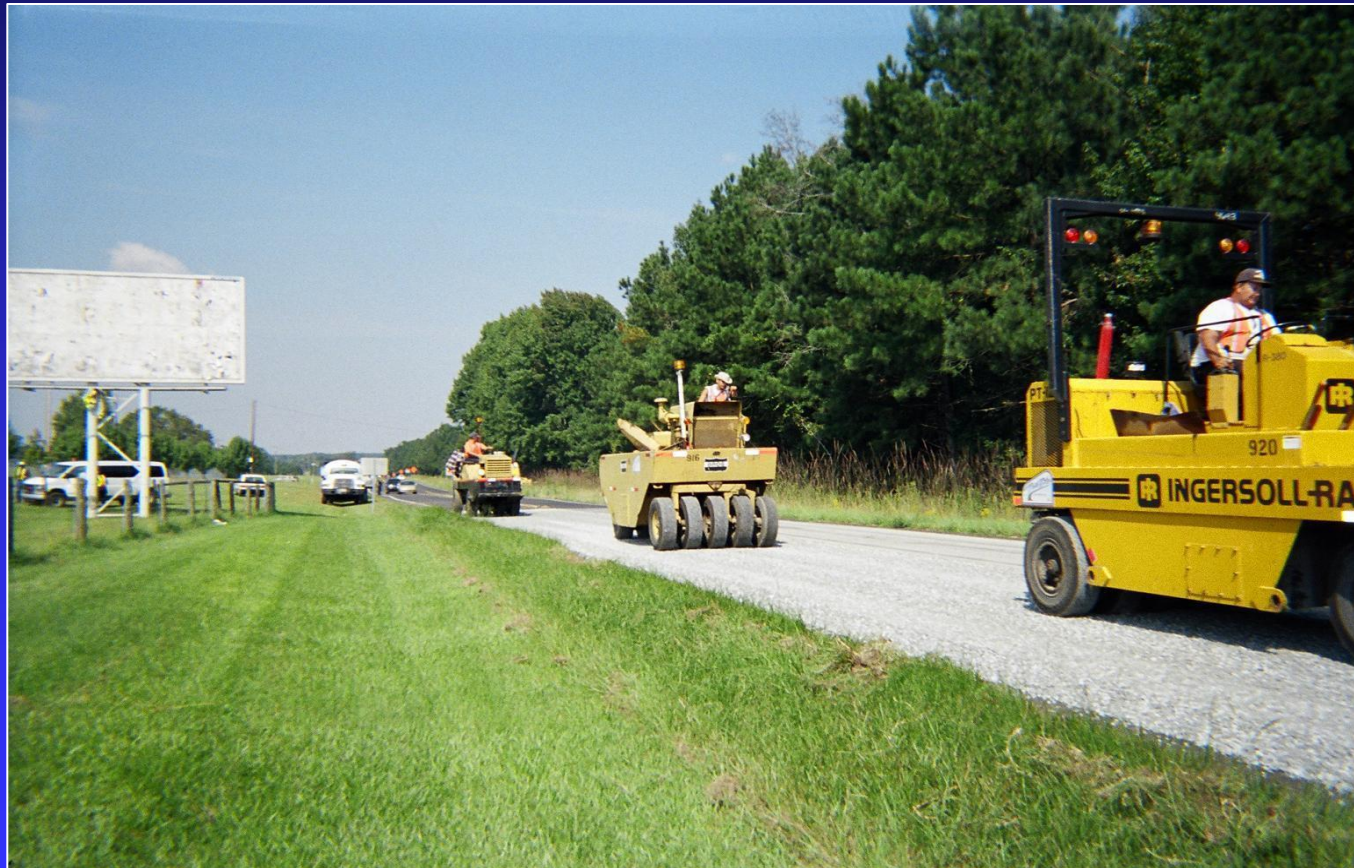
Stress Absorbing Membrane Interlayer Seating Aggregate with Rubber-Tire Rollers

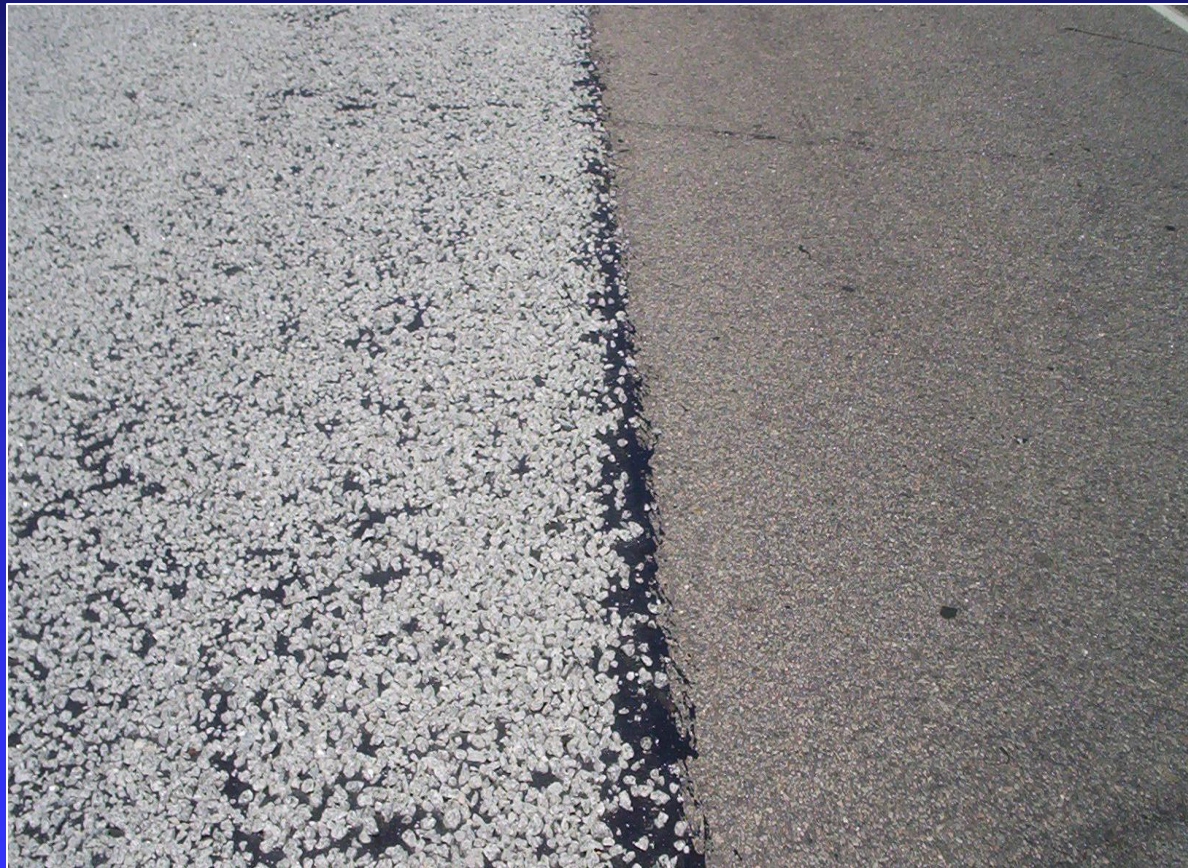
SAMI Left Lane, Existing Pavement Right Lane

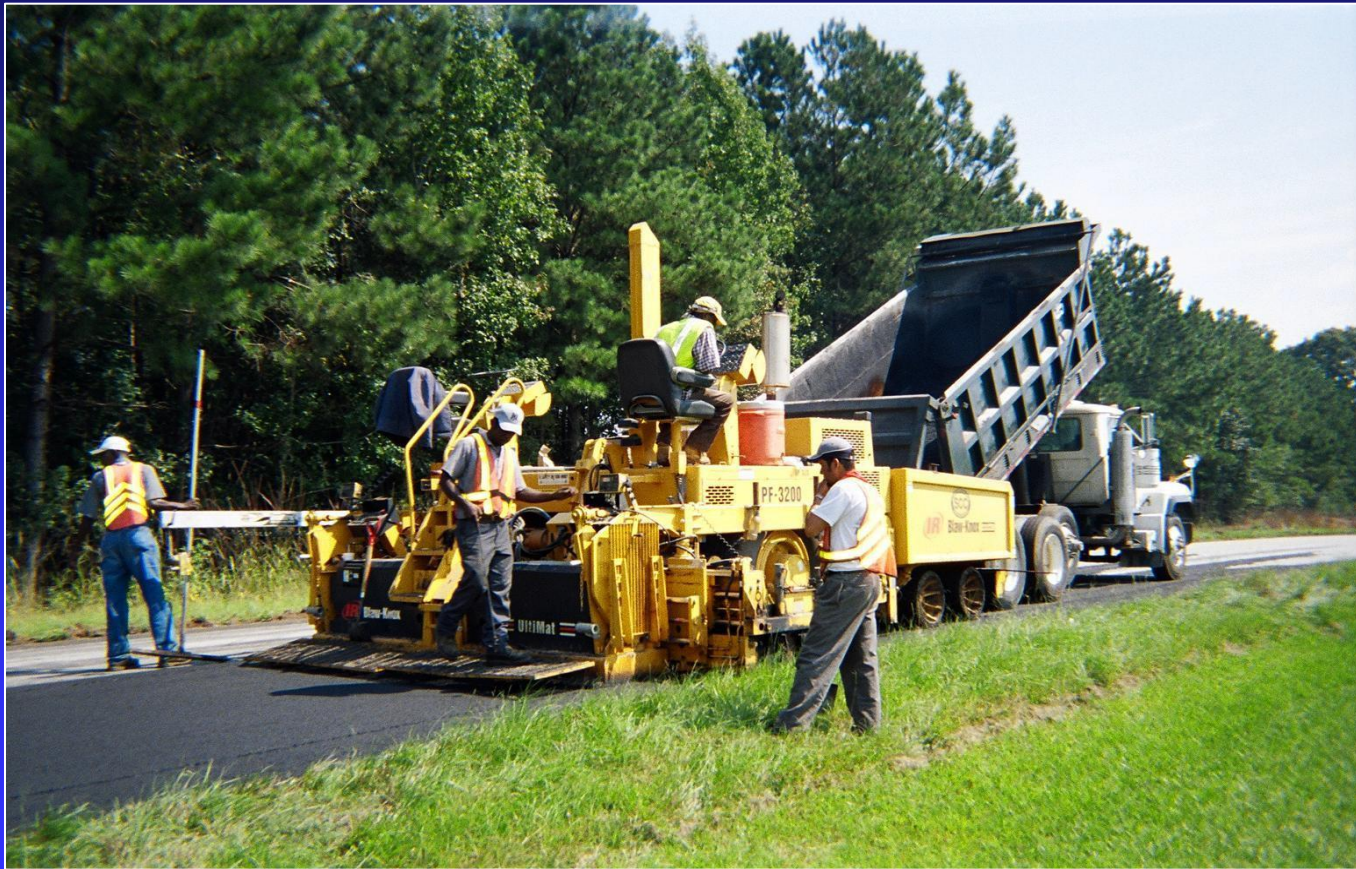
Stress Absorbing Membrane Interlayer Placing HMA Surface over Aggregate Layer

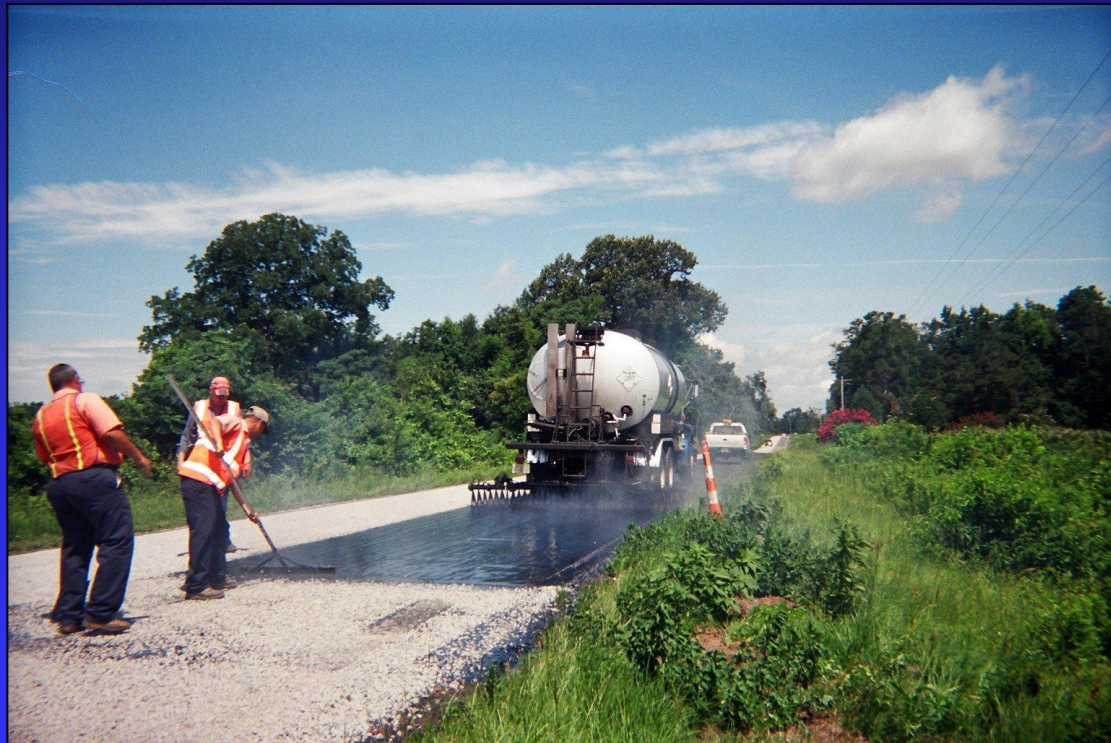
Stress Absorbing Membrane Interlayer

Applying Asphalt Binder Layer
