*Rubberized Asphalt
&
Stress Absorbing Membrane Interlay*

Serji Amirkhanian, Human Being

May 2026

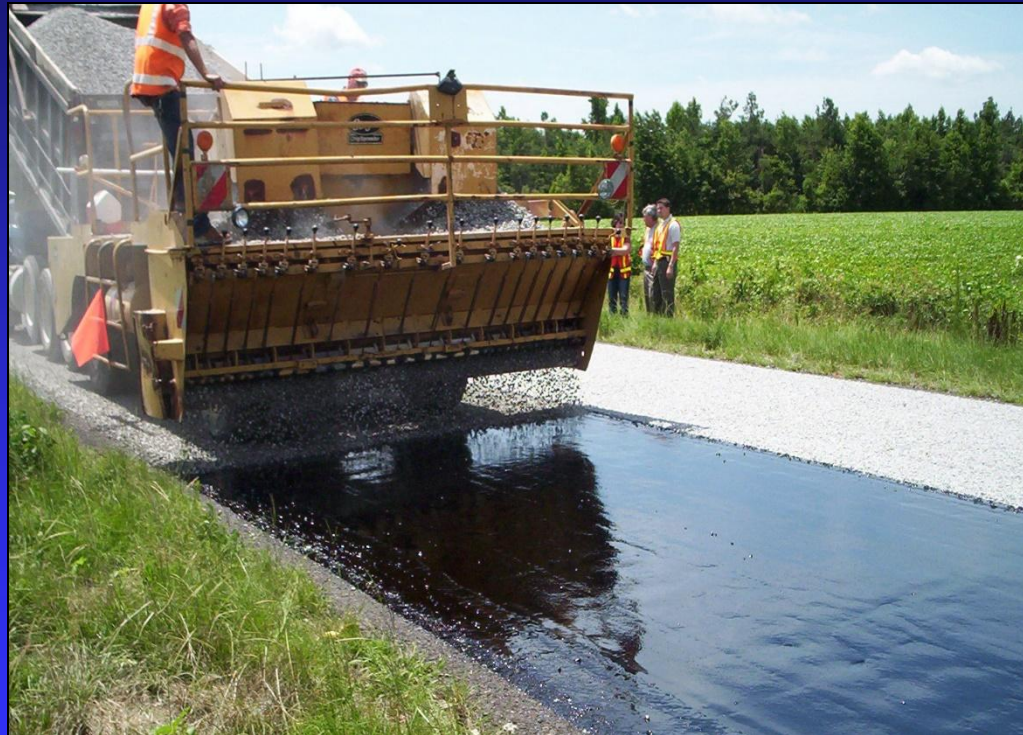
Stress Absorbing Membrane Interlayer

Applying Aggregate to Asphalt Binder Layer

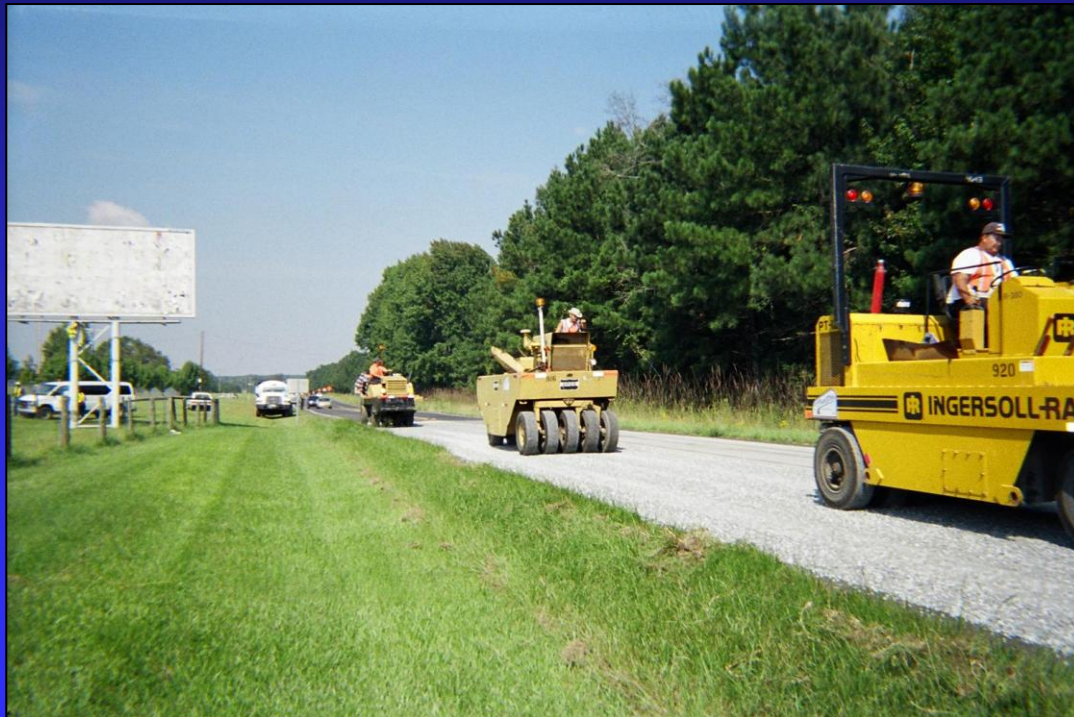
Stress Absorbing Membrane Interlayer Seating Aggregate with Rubber-Tire Rollers

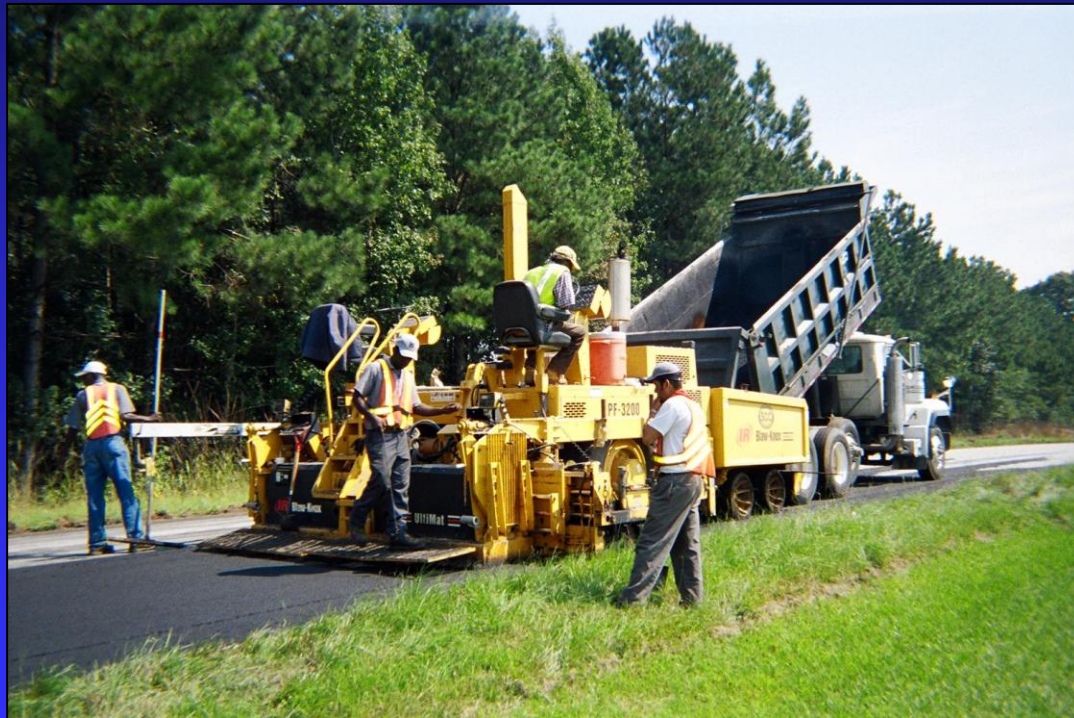
Stress Absorbing Membrane Interlayer

Placing HMA Surface over Aggregate Layer

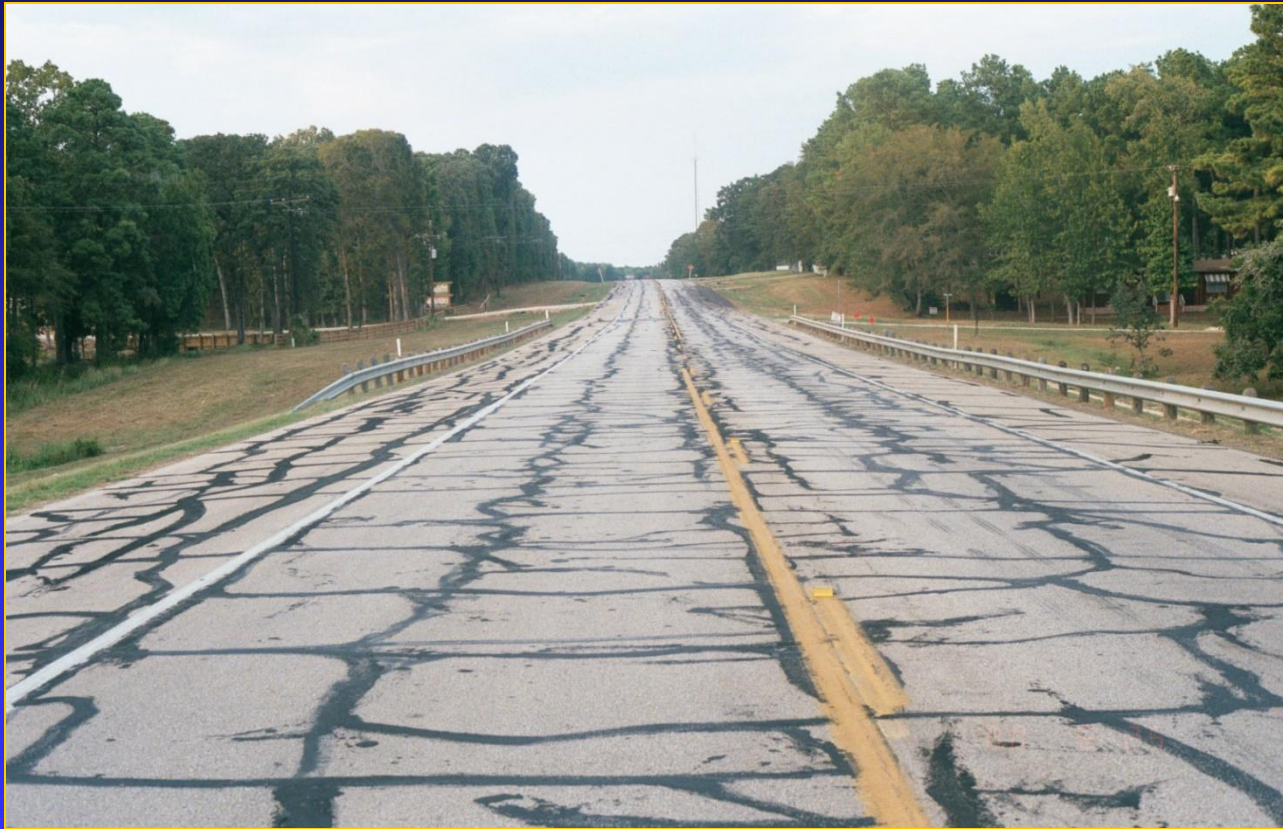
Lubbock, Texas -1985

(Before SAM Application)

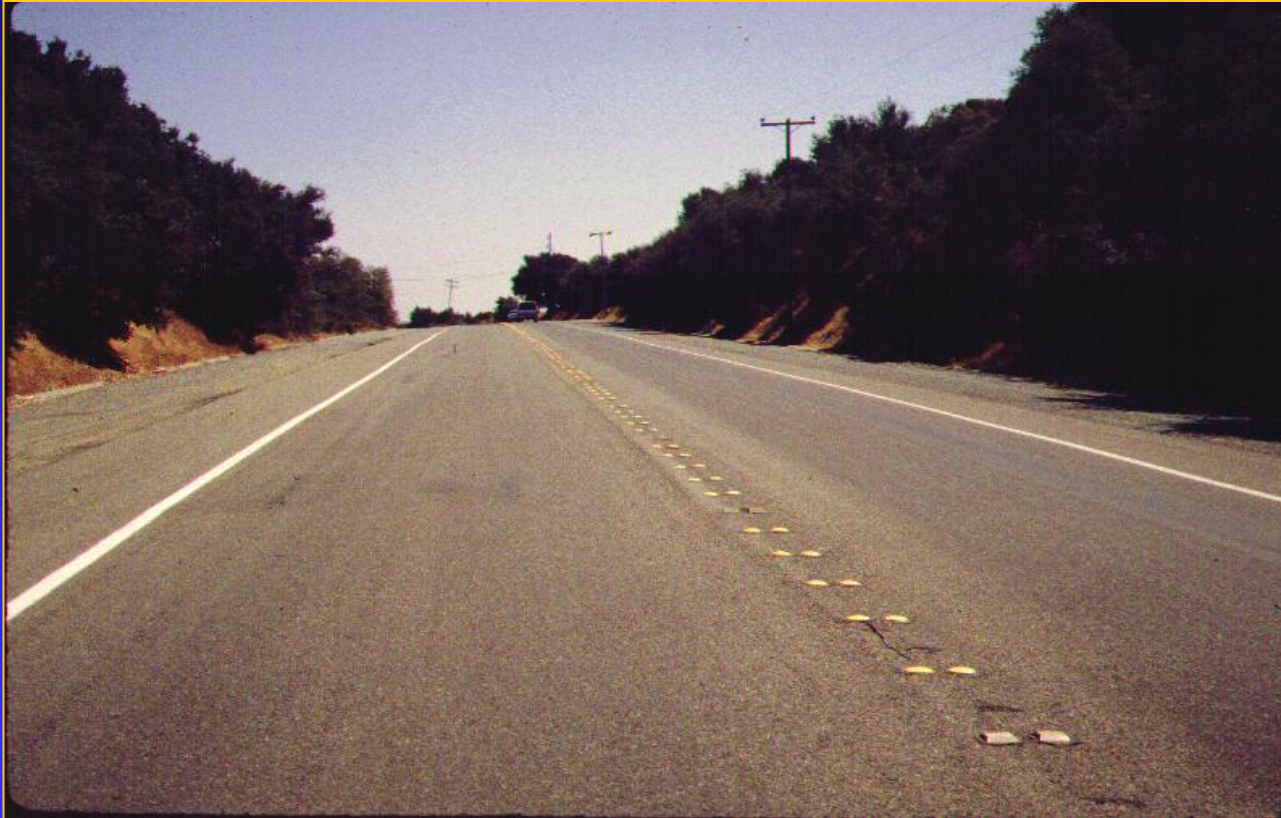
Lubbock Texas - 2000

(After 15 Years of Performance)

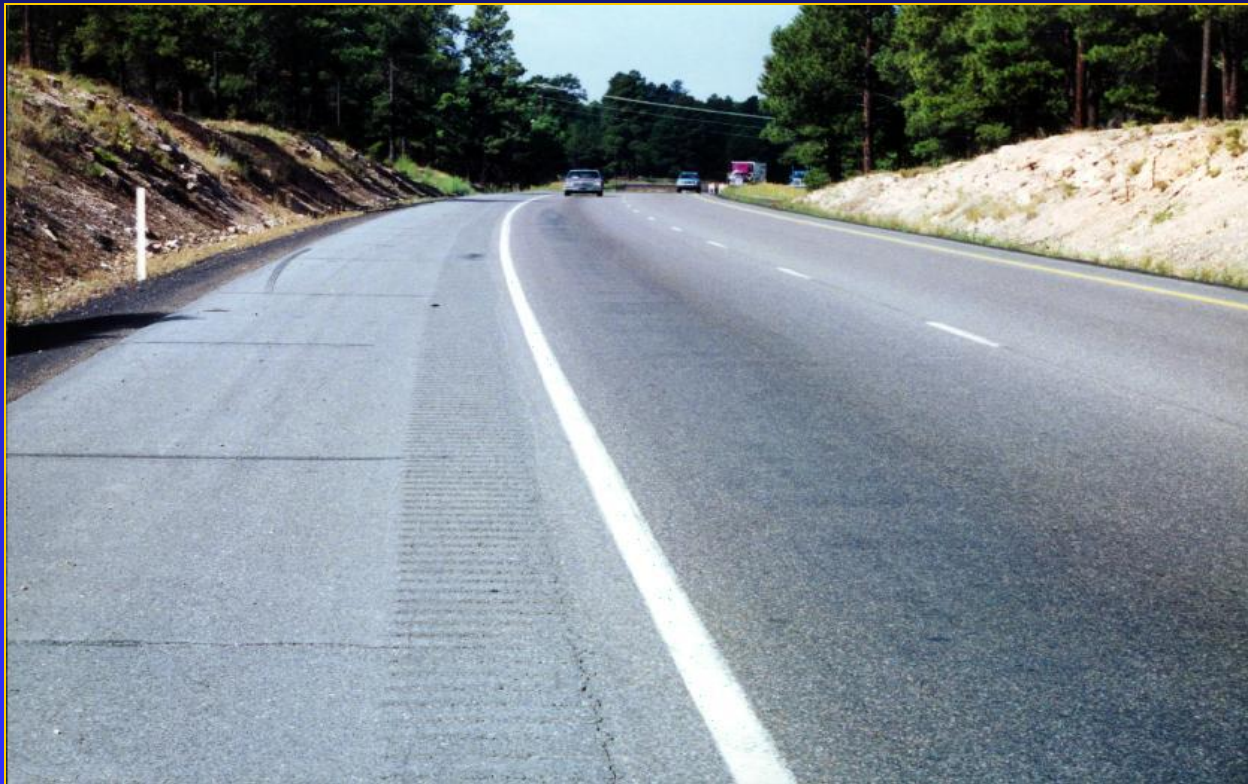
Flagstaff Arizona (2001)

After 12 Years of Performance

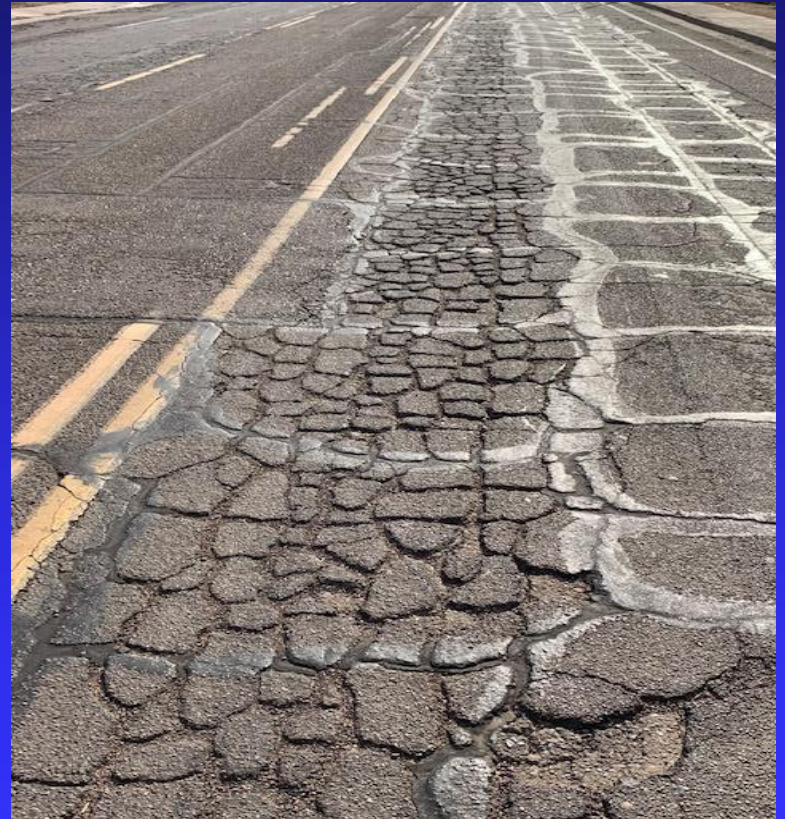
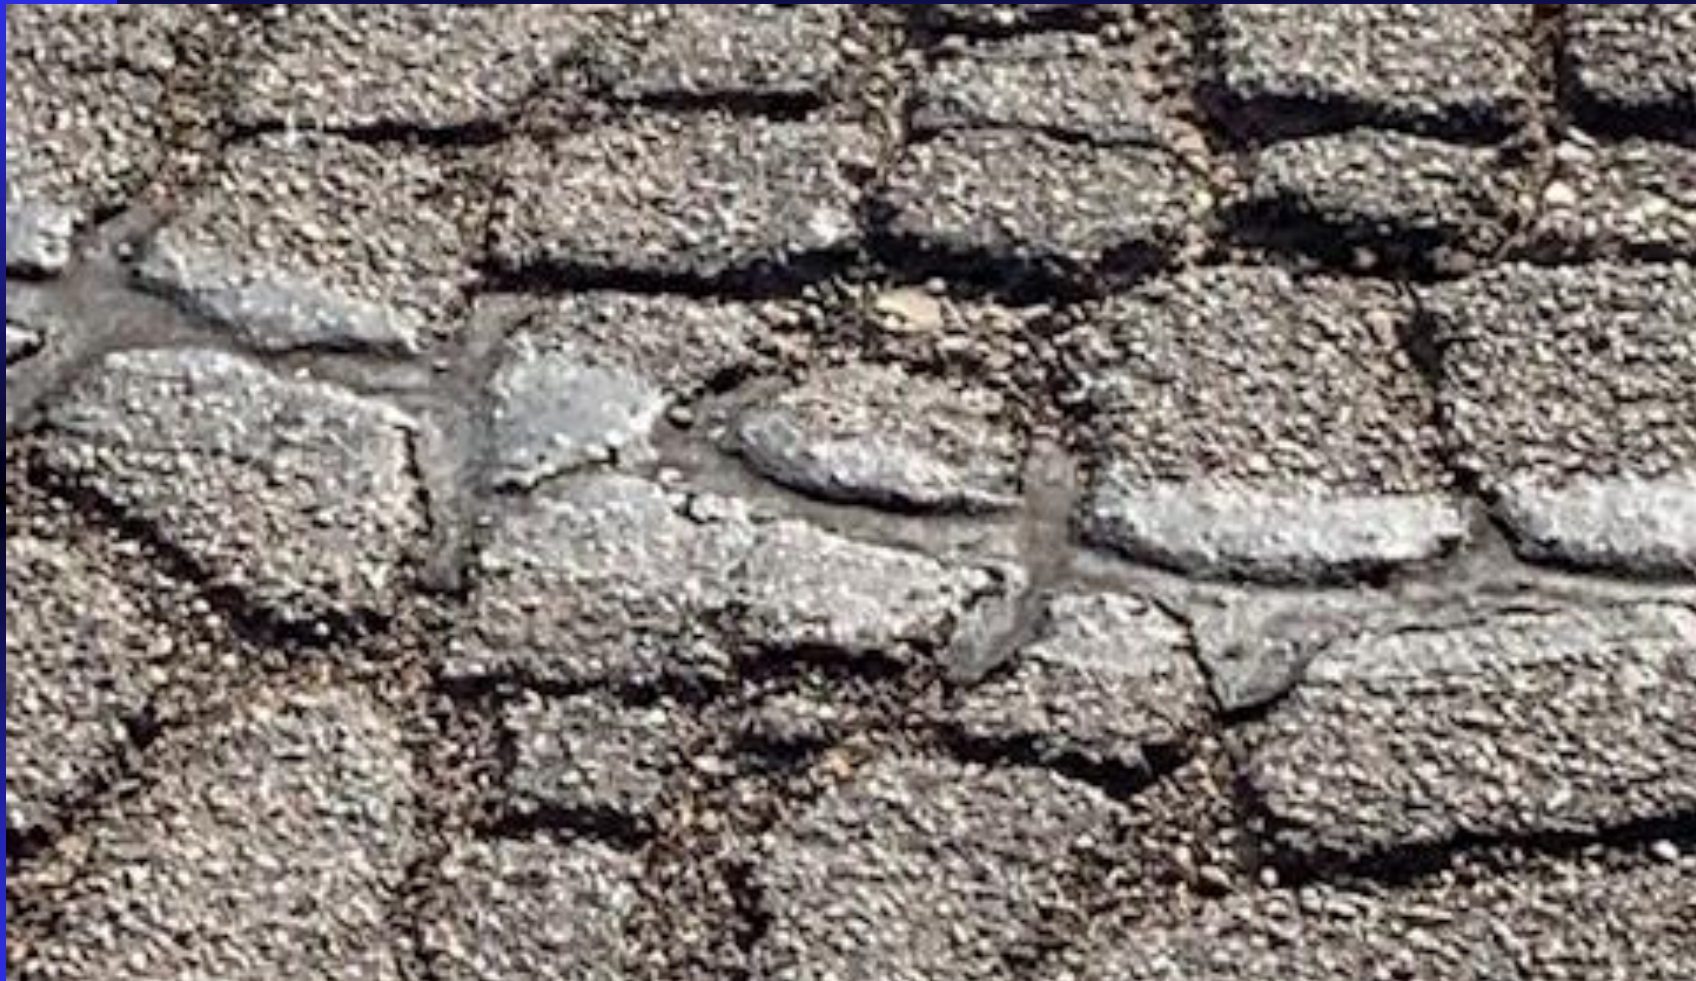
Pavement Condition Prior to Multi-Layer System

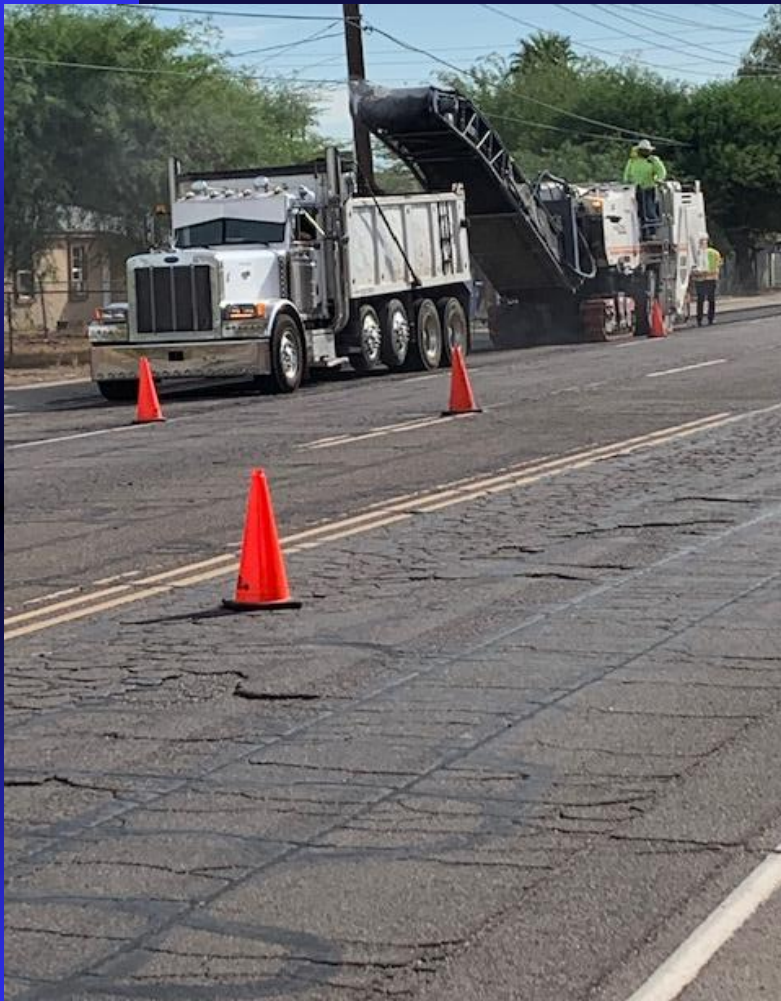
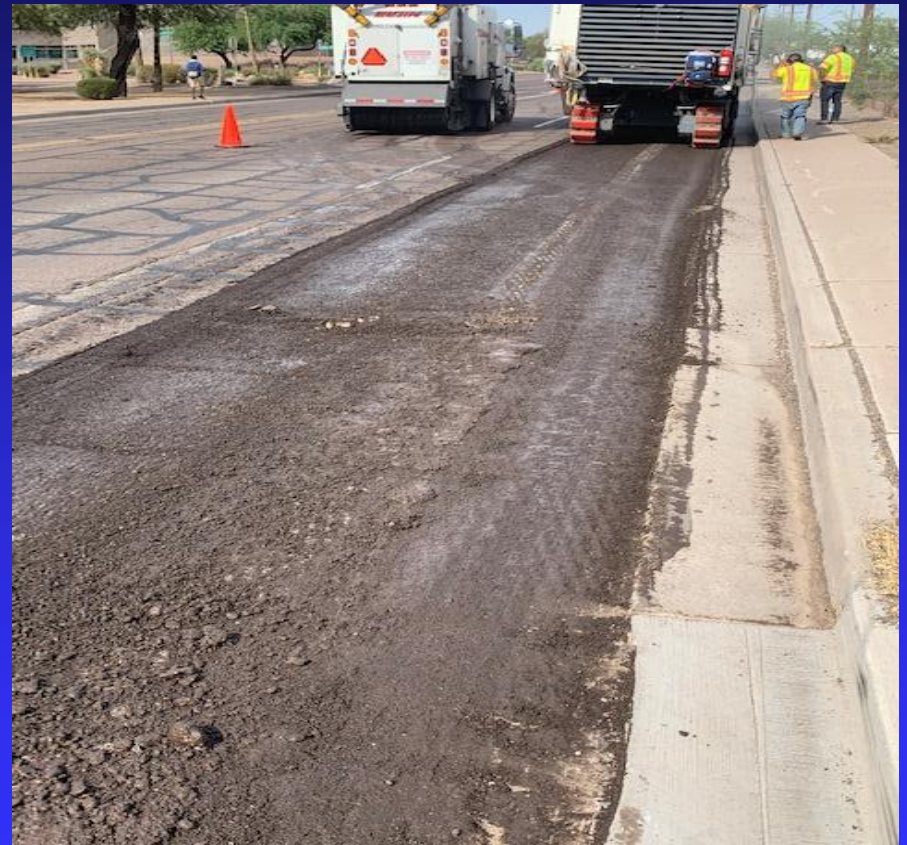
Edge Milling 1½ Inch Depth

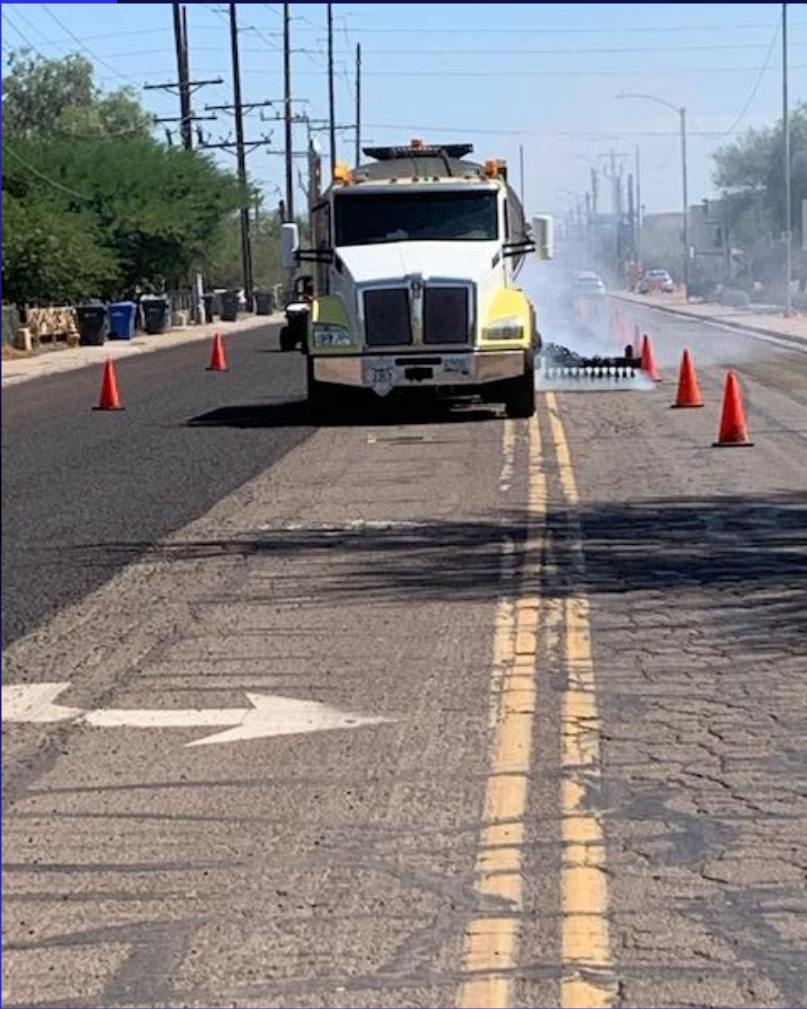
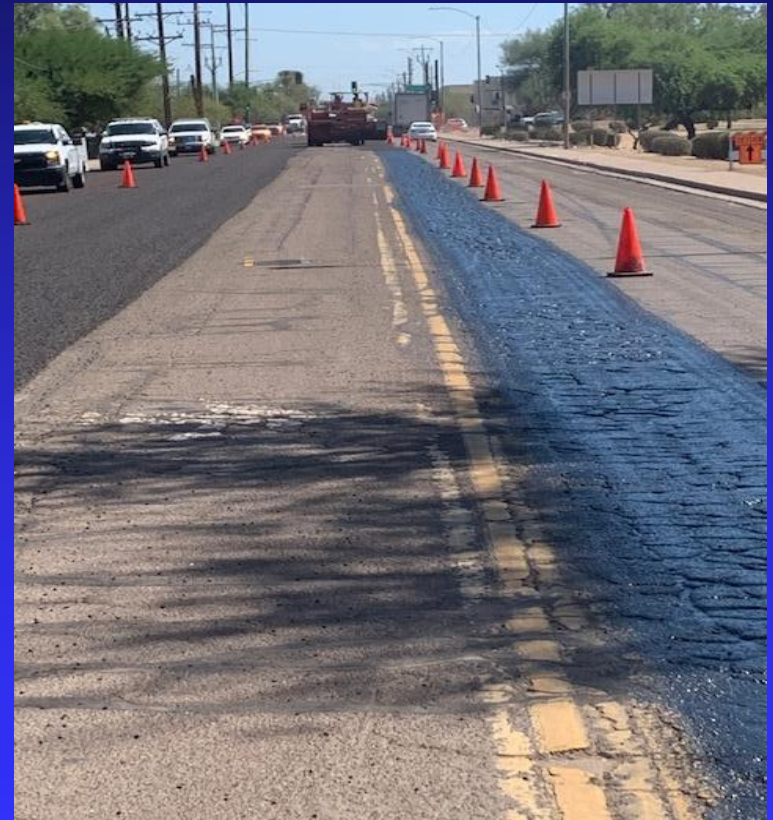
First SAMI Application in Wheel Paths

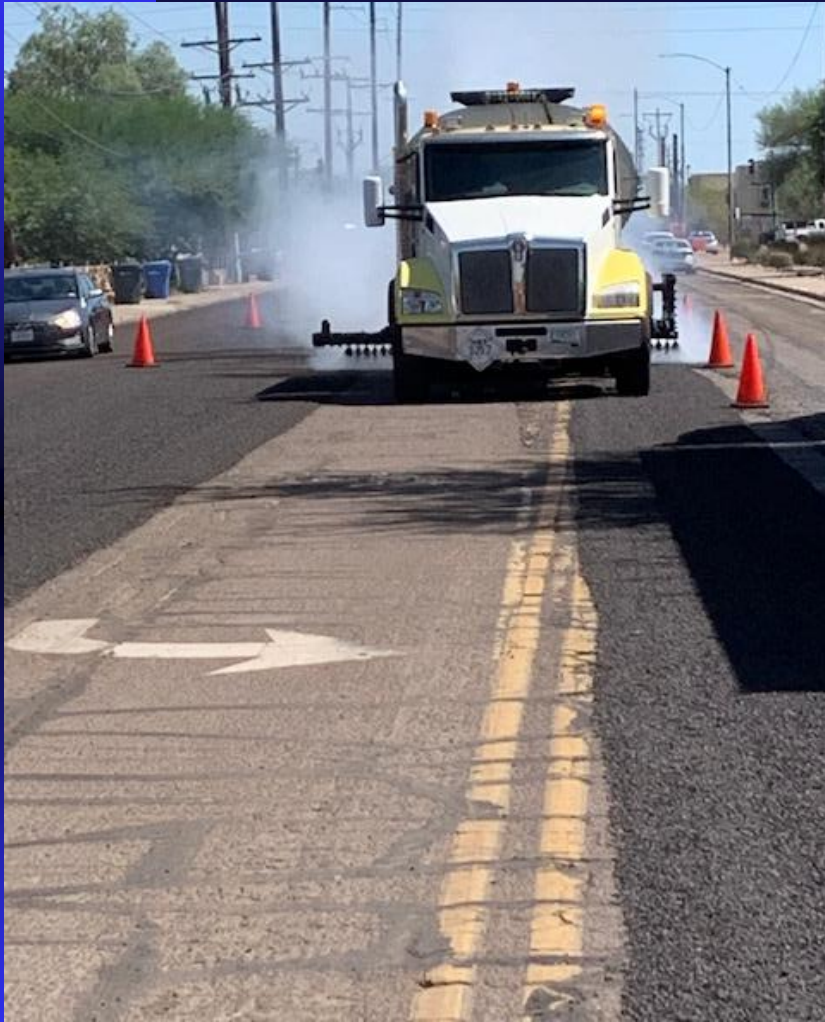
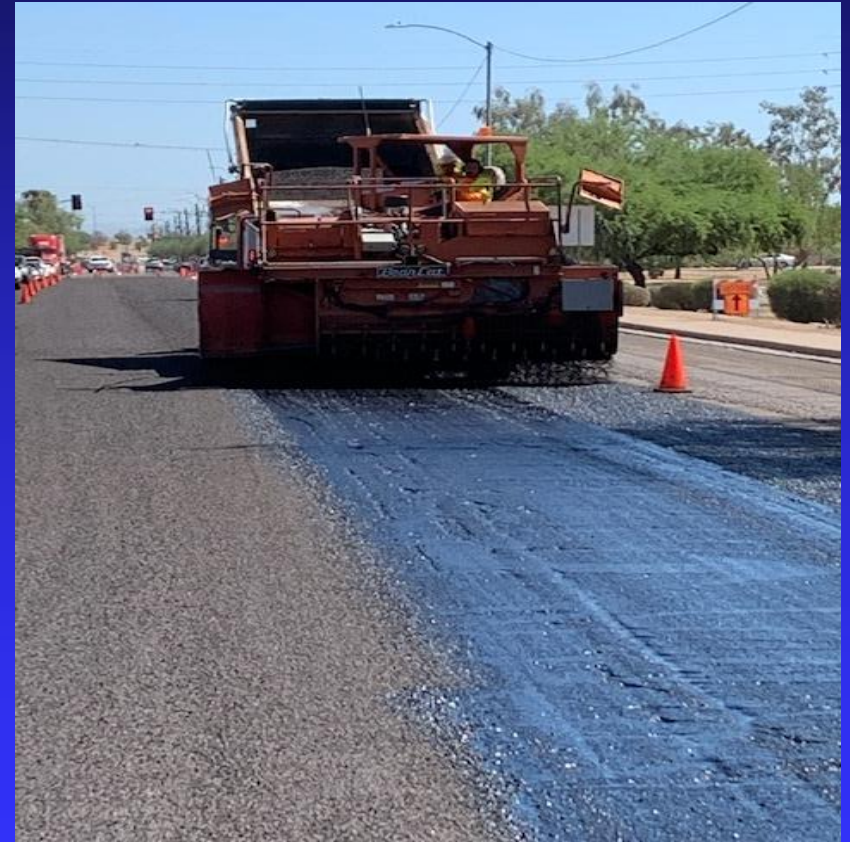
Second SAMI Application Entire Surface

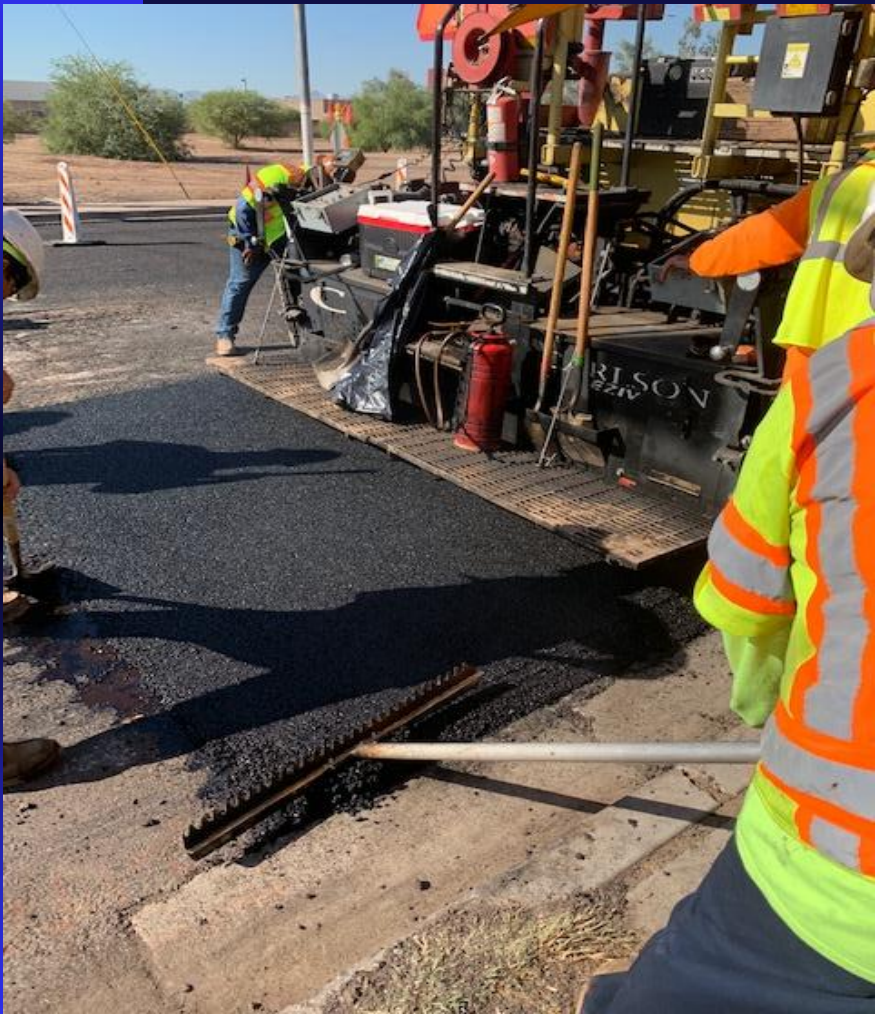
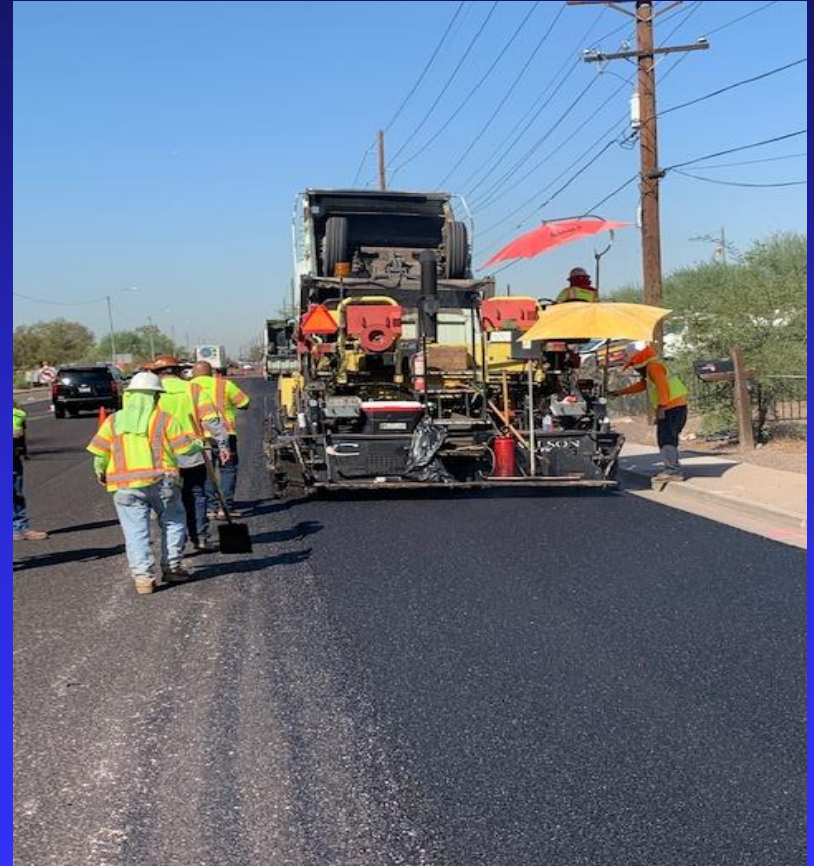
Hot Mix Placement

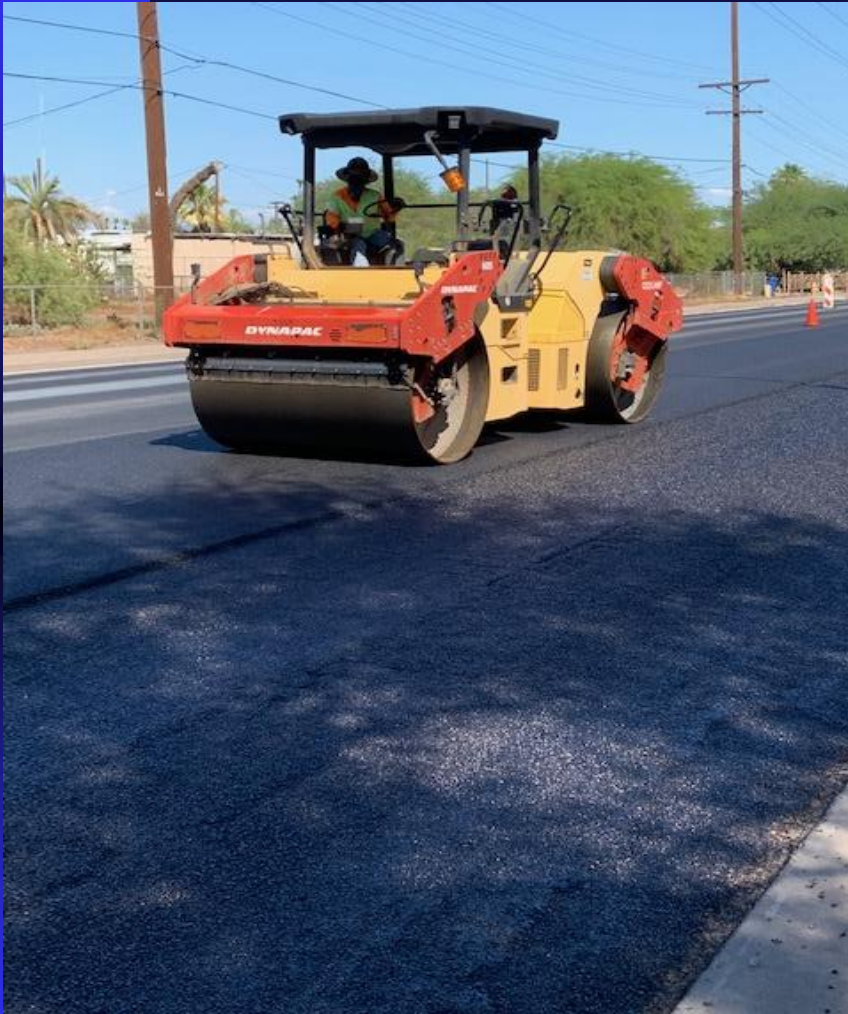
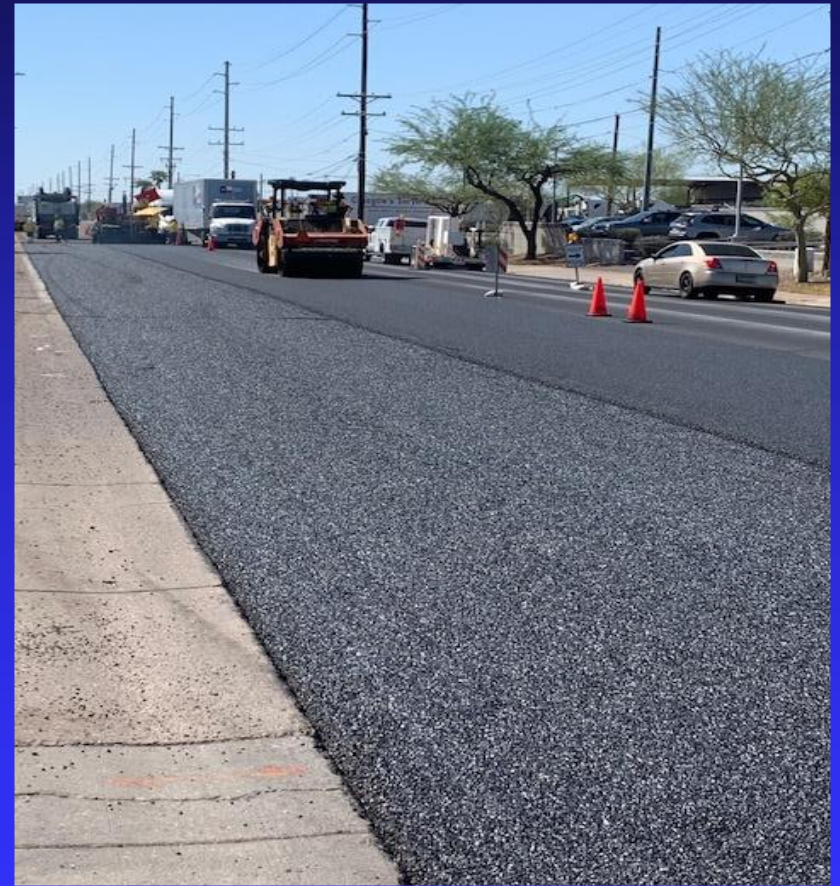
Compaction
